Natural and artificial discontinuities in Boom Clay

Mol (Belgium), February 2000
FB/00-150

EIG PRACLAY

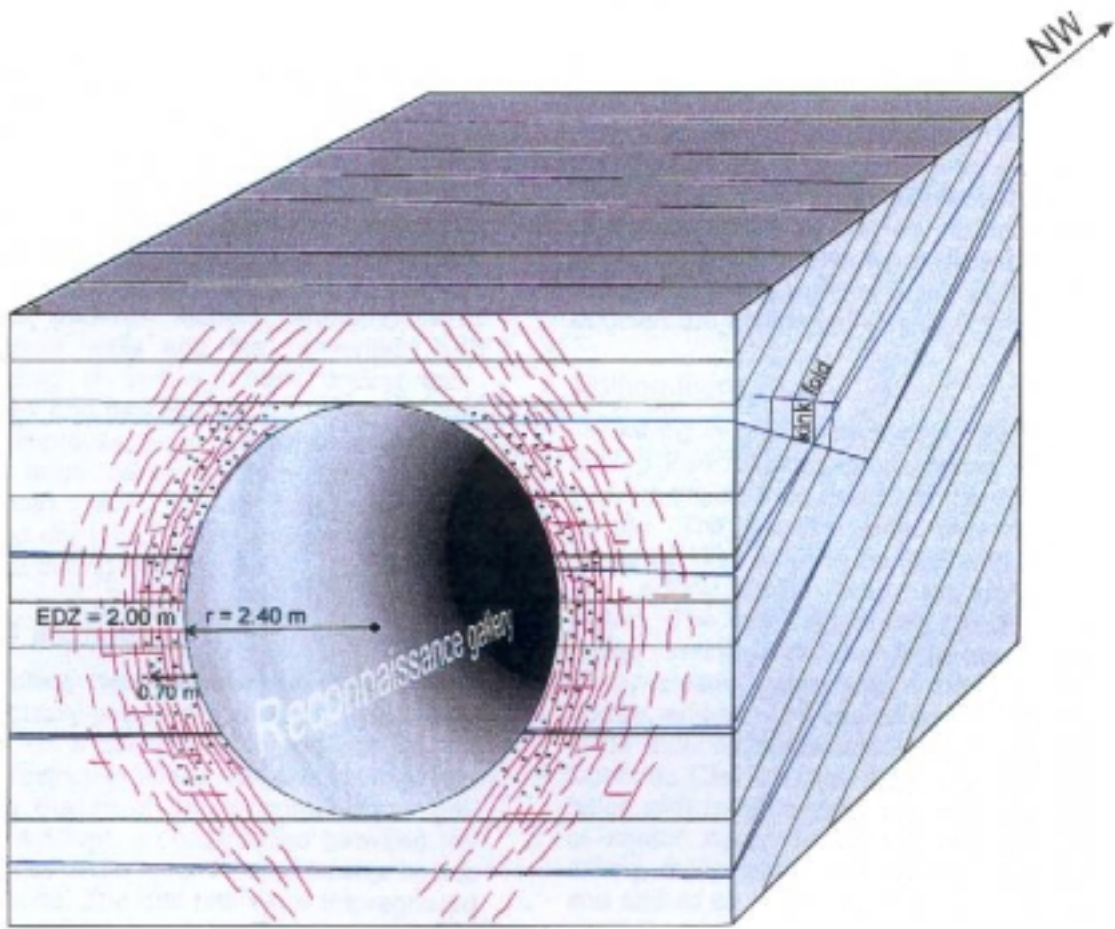
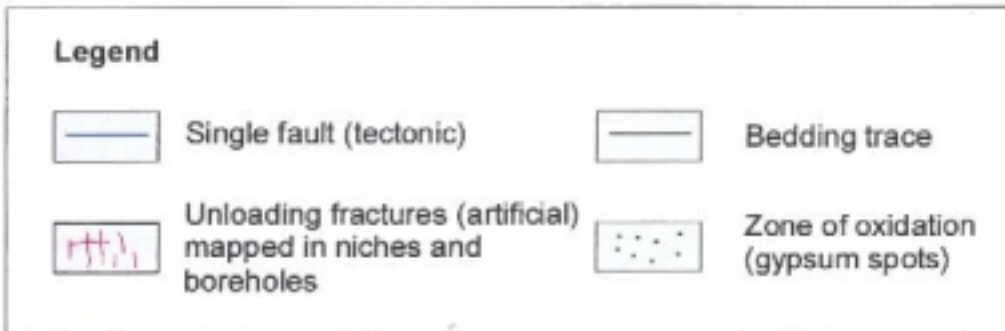
An example is the construction of the Mt. Terri research laboratory (Opalinus Clay in Switzerland). The mapping fractures on drillcores and during the excavation works (galleries and niches) revealed two classes of discontinuities: single tectonic faults and artificial fractures (see Fig. 1). Two groups of artificial fractures were observed. The first group consists of quite recent fractures, oriented parallel to bedding and formed during the excavation of niches by pneumatic hammering. The second, much more important group of artificial fractures, are the so-called unloading fractures. Unloading fractures consist of joints and shear fractures, formed by plastic deformations in the tunnel wall due to tunnel convergence (Thury and Bossart, 1999).

Figure 1: Three dimensional sketch of fractures identified around a gallery (Mt. Terri –Thury and Bossart, 1999)

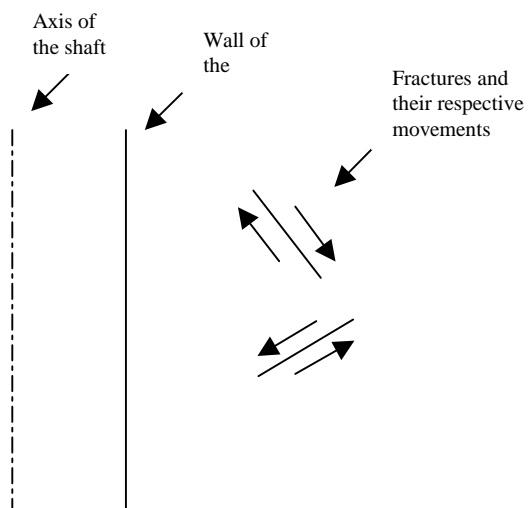
Slickensides (kind of polish, with linear grooves and ridges parallel to the direction of the movement, see Fig. 2) were visible on the slip surface. The shape of the grooves and the ridges indicated a movement in the direction of the centre of the shaft, which can be related to the decompression of the massif (see Fig. 3).

- movement towards the shaft centre is in agreement with the effects of the decompression (see Fig. 3)

Figure 3: Fractures and their respective movements around the shaft

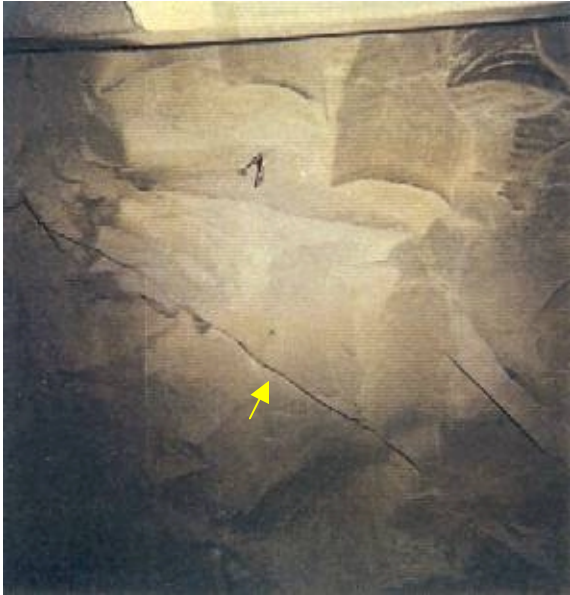
During the excavation of the Test-Drift (1987), discontinuities were observed (mainly on the lateral walls) in the clay mass (see Pictures 1 and 2). These discontinuities were without consequences for the stability of the gallery although their presence caused some problems during the digging works and led to a slightly larger excavation profile at the roof. The orientation of the discontinuities was systematically registred (mean orientation: strike direction N100 dipping 16S). It was concluded that all fracturation planes encountered in the gallery are resulting from a combination of the stress-state of the pre-existing fractures of Boom Clay and new decompression planes due to the excavation (Van Cotthem, 1988).

Picture 1: Fractures observed during the excavation of the Test Drift (1987) – East lateral wall

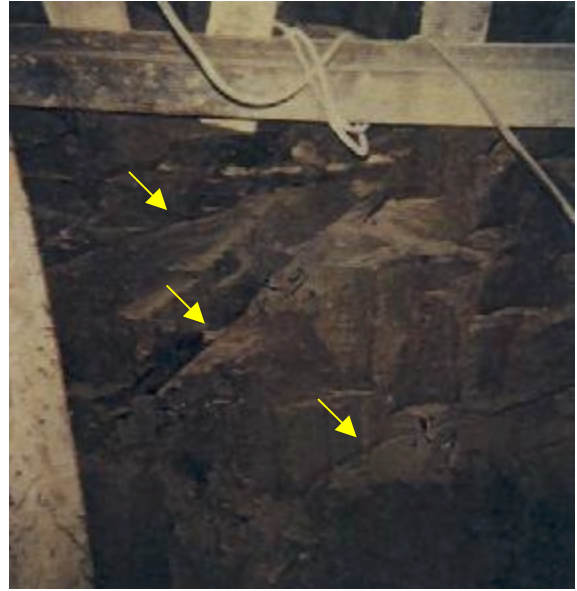
Picture 2: Fracture observed during the excavation of the Test Drift (1987) – West lateral wall

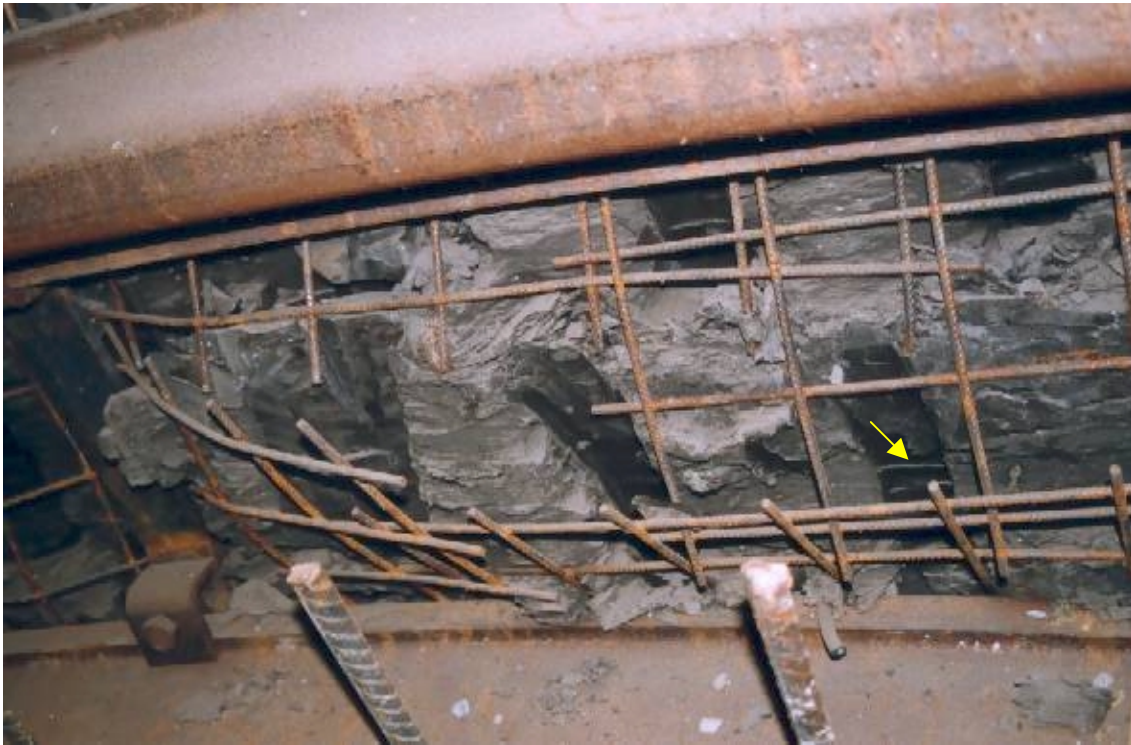
During the excavation of the second shaft (1998-1999), sub-horizontal fractures were observed on the lateral wall dipping towards the centre of the shaft (see Picture 3). The fractures were symmetric around the axis of the shaft. The length of the fractures ranged between a few cm to 100 cm and was not continuous on the circumference. Fractures were opened about 1 mm and spaced about several meters.

Picture 3: Degraded rock on the lateral excavated wall of the second shaft (1998)

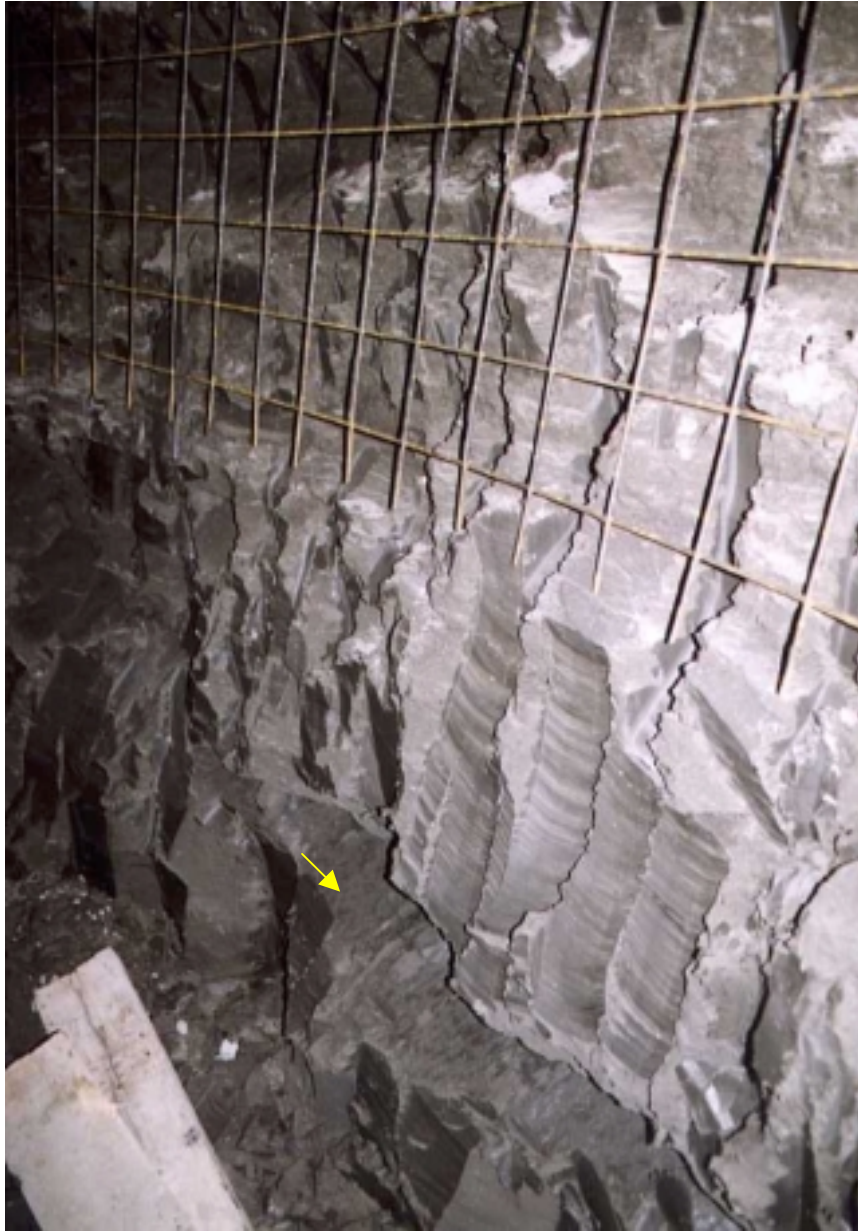
During the enlargement of the foundation, detachment of large clay blocks and slip planes (similar to those encountered during the excavation of the starting rooms on the bottom of the shaft) were observed - see Picture 4. At this time, the encountered slip planes did not cause major problems to the contractor.

Picture 4: A slickensided surface observed during the enlargement of the foundation (1998)

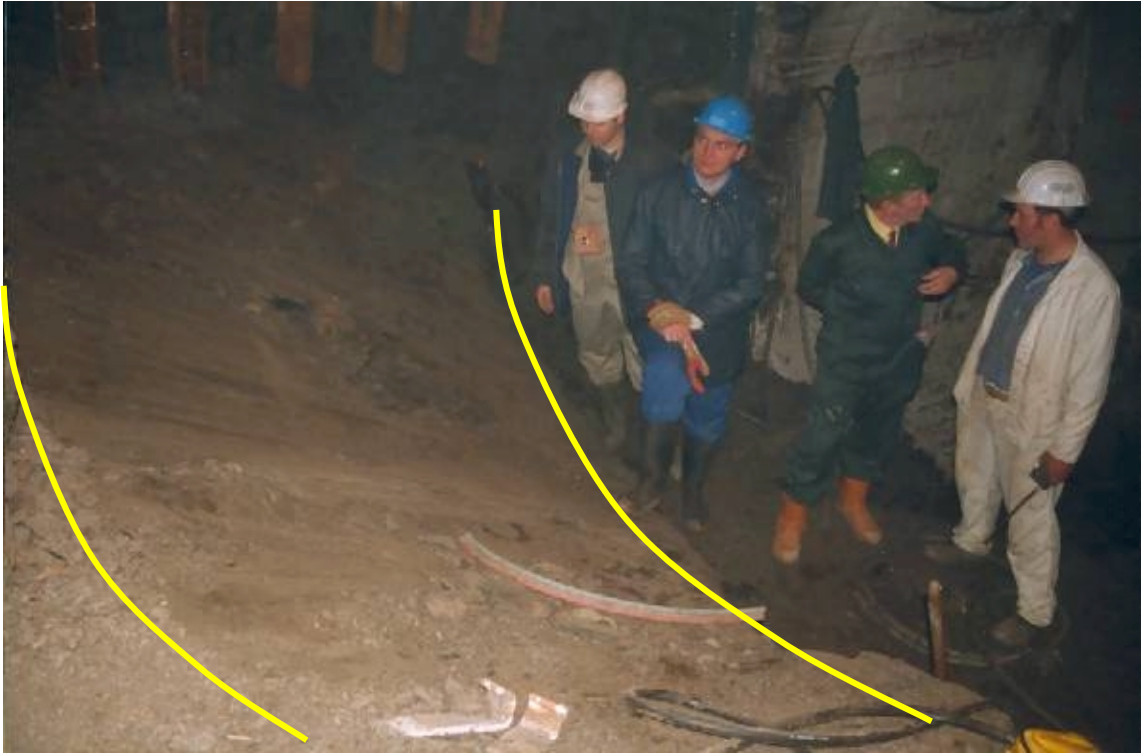
During the excavation of the starting rooms at the bottom of the shaft, large slip planes (about the whole section of the gallery: ~ 7 m) have been observed both on the North and the South side. They consist of an interconnected network of conjugated planes (N90- 35N; N90-35S). This direction is different from natural fractures. It could be interesting to compare these directions with the directions of the fractures observed in open pit. The circular shape of the slip planes (as we can observe on Picture 5) leads to think that the fractures are symmetric around the shaft axis. They were visible on the front and on the lateral sides (see Pictures 5, 6, 7). The fractures were initially closed and were opened during the decompression process up to detachment of some blocks (see Picture 8).

Picture 5: A slickensided surface circular shaped observed in the South starting room (1999)

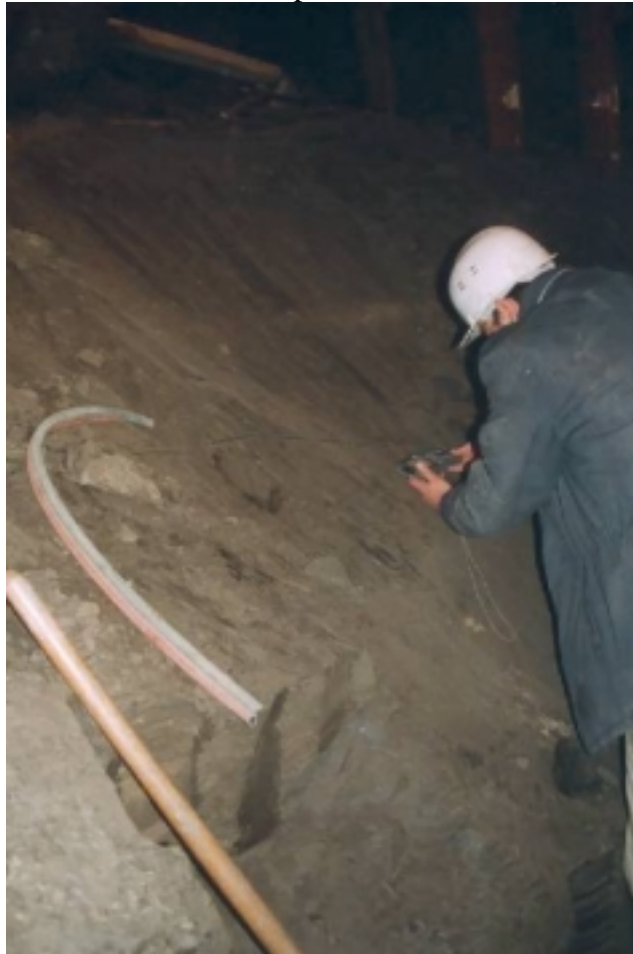
Picture 6: A slickensided surface circular shaped observed in the South starting room (1999)

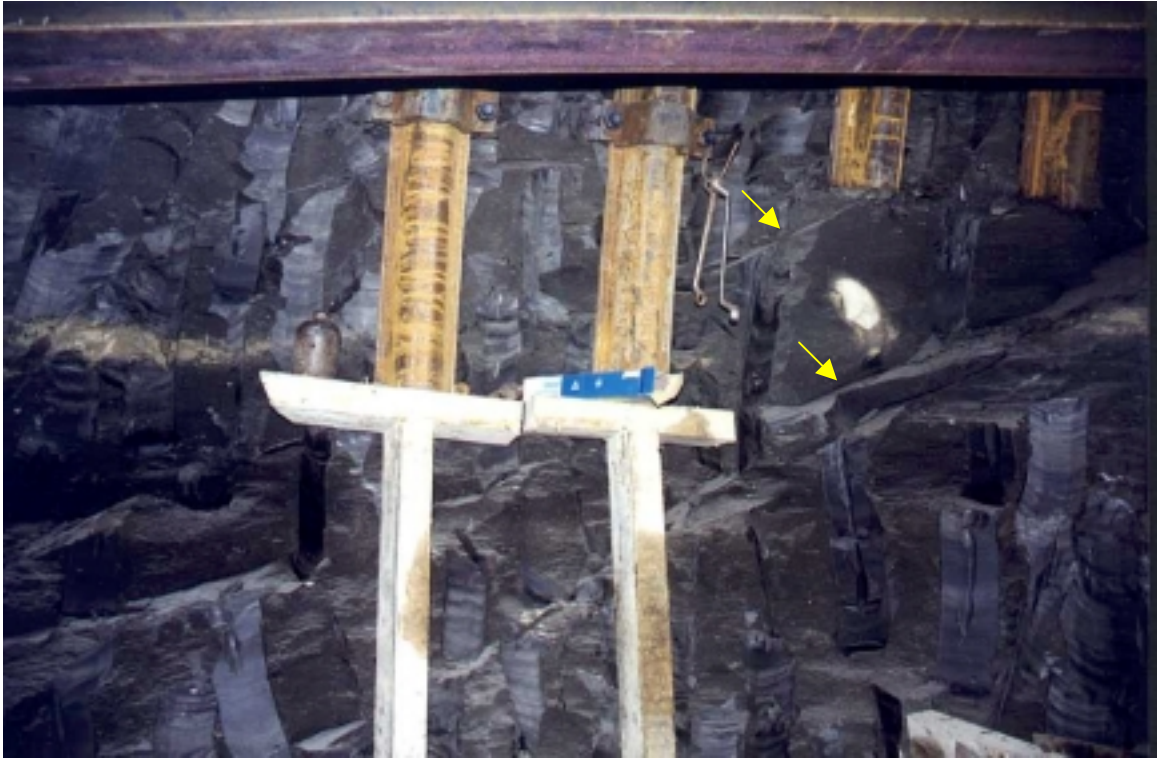
Picture 7: Fractures observed on the lateral wall of the South starting room (1999)

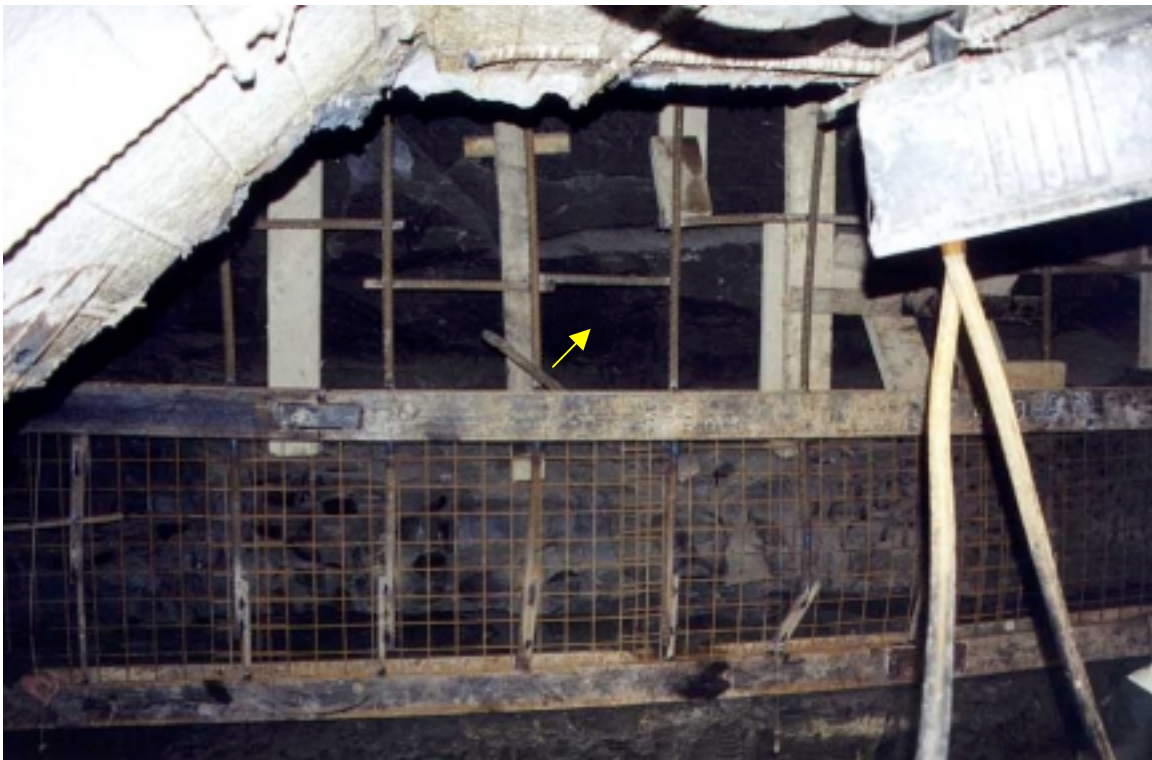
Picture 8: Void created by the detachment of a large clay block at the front of the South starting room (1999)

No active support was installed from the beginning of the excavation works of the starting rooms. Indeed, in the first excavation phase, support was installed mainly to protect the miners and not to limit the convergence. This and the low excavation rate have surely favoured the opening of the pre-existing fractures and/or the induction of new fractures due to the excavation. The installation of an active support in the last excavation phase has considerably improved the behaviour of the rock.
