# Characterisation of induced discontinuities in the Boom Clay around the underground excavations (URF, Mol, Belgium)

J. Mertens<sup>a,\*</sup>, W. Bastiaens<sup>b</sup>, B. Dehandschutter<sup>c</sup>

Excavation works were carried out in Boom Clay to extend the underground research facility in Mol (Belgium) located at a depth of 223 m below the surface. The attempt to characterise the extent of the Excavation Damaged Zone, or EDZ, around the second shaft, using seismic measurements and cored borings, was successful, as proven by observations during further excavation works in the investigated area. No evidence for the occurrence of natural discontinuities was found. Using an industrial technique, an 84-m-long gallery was excavated in the Boom Clay. These excavation works induced a symmetrical pattern of discontinuities and clearly limited the EDZ extent.

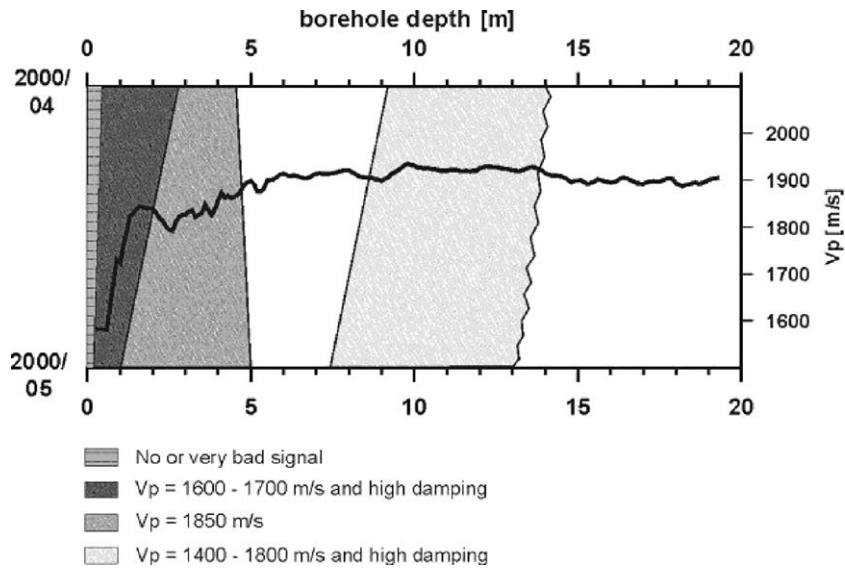
Fig. 4 shows the main results from the campaign. It appears that the rock mass is damaged with a lot of small-scale disturbances up to approximately 2 m (2.8 m in 2000–4 and 1 m in 2000–5). The region between 2 and 5 m shows less small-scale disturbances. It can be noticed that this zone presents a gradual increase of the P-wave velocity to an average level of 1900 m/s. An explanation for the phenomenon of the cross-hole P-wave velocity increase might be the increasing stress around the borehole with increasing distance from the second shaft and/or a decrease in the amount or the influence of fractures.

From their measurements, BGR concluded that there are indications that the EDZ extends to approximately 5 m into the clay body. A remarkable differentiation between the depth ranges 0.3–2 m and 2–5 m was noticed.

Fig. 4. Results from the seismic campaign by BGR. The curve shows the result of the cross-hole seismic measurements. The shaded surfaces are the correlations between both single-hole measurements. According to BGR, there are indications that the EDZ extends up to 5 m into the clay body.

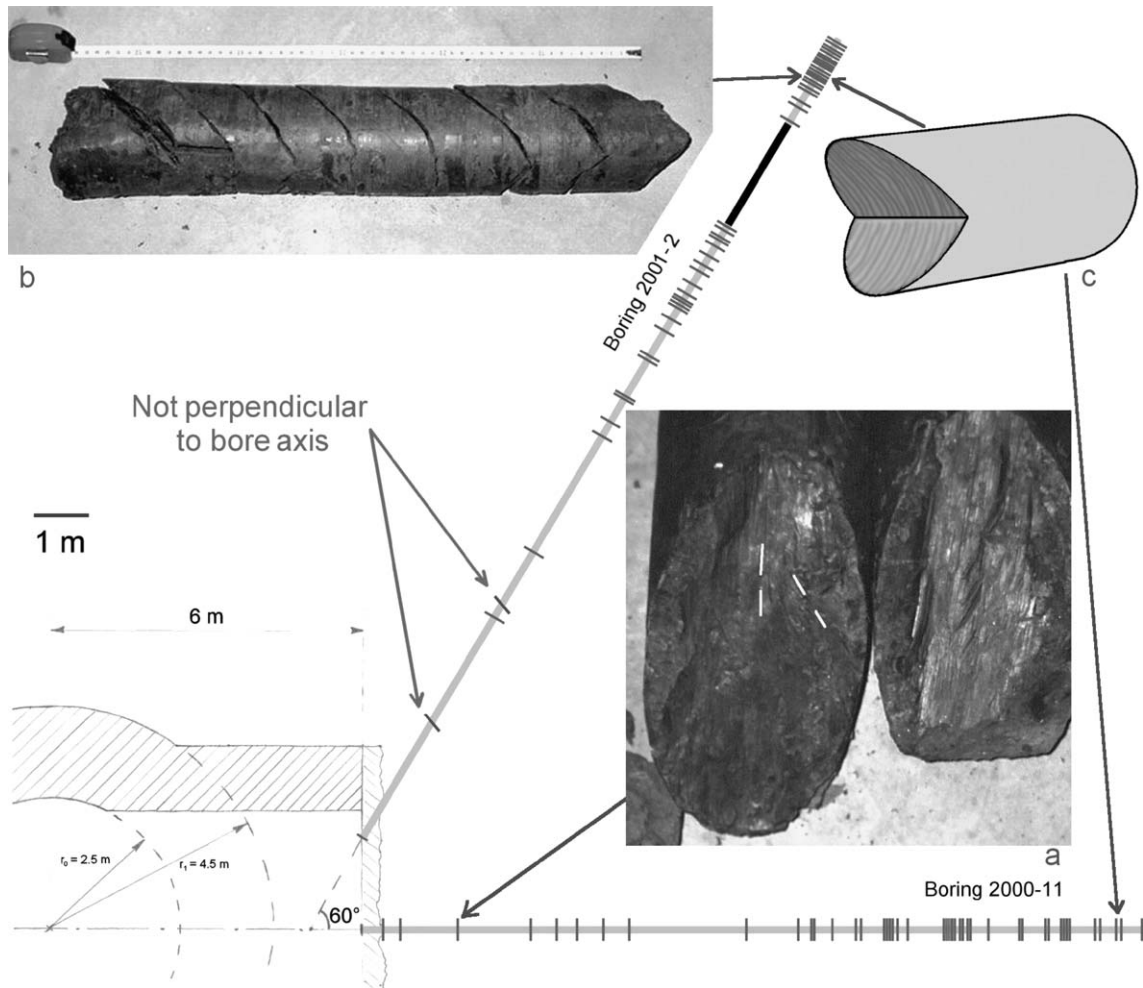
Looking at Fig. 5, showing a plan view of the strike of all discontinuities encountered, it can be concluded that all but two discontinuities, located in 2001–2, have a strike perpendicular to the borehole axis. All discontinuities show striations, indicating a shear origin. The Striations appearing on the two out-of-line discontinuities are, however, more outspoken than the ones appearing perpendicular on the borehole. Dips are both directed towards the Mounting Chamber and away from it.

In Fig. 5b, part of the last core taken from borehole 2001–2 is pictured. One can notice the intense fracturing due to the drilling process. A high concentration of these fractures, most of them appearing in pairs creating the form of bills of birds (Fig. 5c) appeared in the last cores of both drillings. Dips varied between  $40^\circ$  and  $60^\circ$ . It is clear, taking into account the strike of the discontinuities, that they are formed due to a relaxation of the clay in the direction of the bore axis. The fact that they do not appear in the first meters, or at least show a much lesser intensity there, can easily be explained by the allowance of a large convergence of the clay after the excavation of the second shaft and the Starting Chamber. The clay mass experienced relaxation, and the stresses are low in the first meters.

Fig. 5. Plan view of encountered discontinuities in the cored borings. In (a), a fracture containing striations in two directions is pictured. In (b), a picture from the highly fractured core near the end of the borehole is shown. In (c), the typical form of conjugated fractures in the cores near the end of the borehole is drawn. Unfortunately, core X in borehole 2001–2 was lost due to pyrite obstruction in front of the core-mouth.

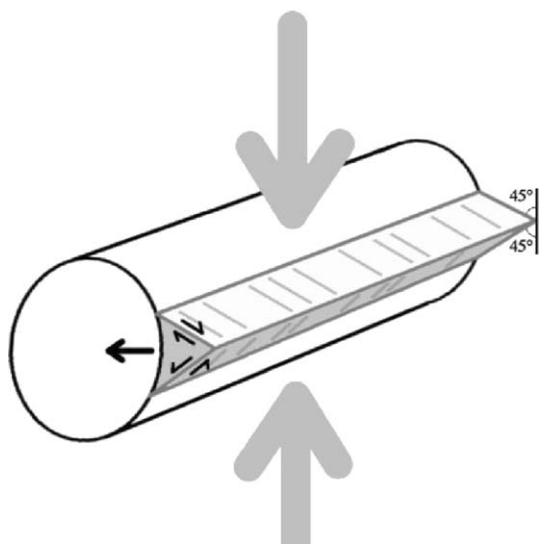
Another drilling effect, noticed when entering the borehole with a camera was that in the deeper part of the boreholes (7–15 m) pieces of clay, as indicated in Fig. 6, were expelled from the sidewalls of the borehole. These pieces were often recovered in the core tubes. The form of the borehole in this zone was very irregular. On the contrary, in the first meters of the borehole, the walls appeared to be rather intact. Again, this can be explained by relaxation of the clay in the first meters.

Fig. 6. Drawing of the expelled clay pieces along the borehole. These pieces were often recovered in the cores. They are clearly borehole breakouts which took place after the drilling process.

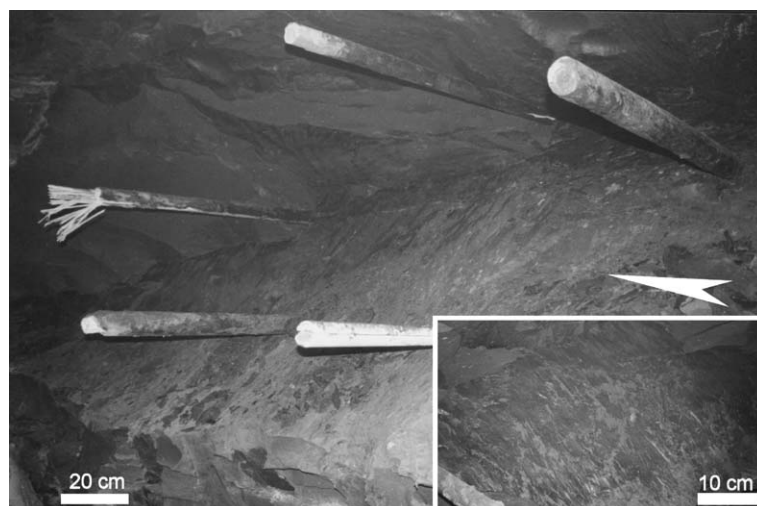
The most dominant discontinuities observed in the front are large ( $>3 \text{ m}^2$ ) slickensided shear planes, containing clear striations (Fig. 7). The planes are dipping towards the centre of the second shaft. They are more or less parallel and have an average spacing of around 70 cm. Their strike is  $\pm$  EW on an average. The dip ranges between  $30^\circ$  and  $70^\circ$ , due to the fact that most of the shear planes were curved in such a way that their dip increased with increasing distance from the shaft.

Fig. 7. Pictures of the large shear planes. One can see the safety anchors sticking out of the clay (the anchors are pointing towards the Starting Chamber). The surfaces contain clear striations.

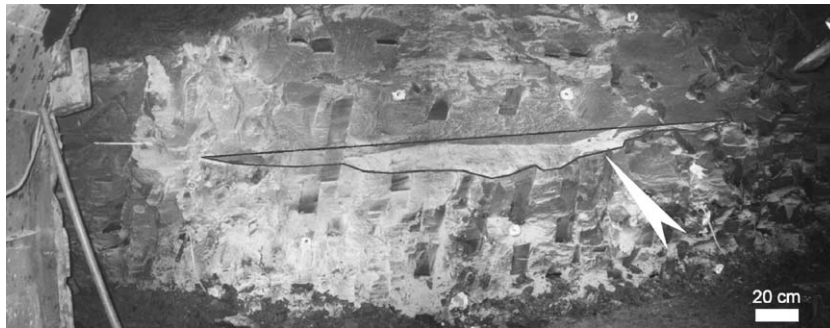
Especially in the first 1.5 m of excavation, the cross-section between these planes and the front always appears in the form of a bow (Fig. 8).

Fig. 8. Picture showing clearly the bowed cross-section of the fractures and the front, indicating that the shear planes are not straight planes, but are more or less circular around the axis of the second shaft.

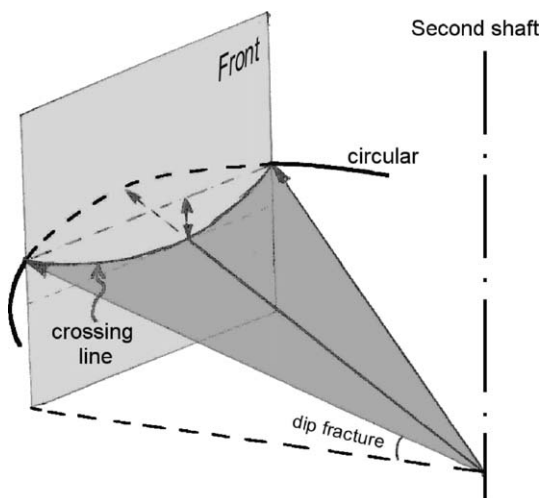
This supports the hypothesis that these planes are roughly circular around the second shaft (Fig. 9). The planes are continuous over the whole front width, and

Fig. 9. Drawing explaining the bowed cross-section of the fractures and the front.

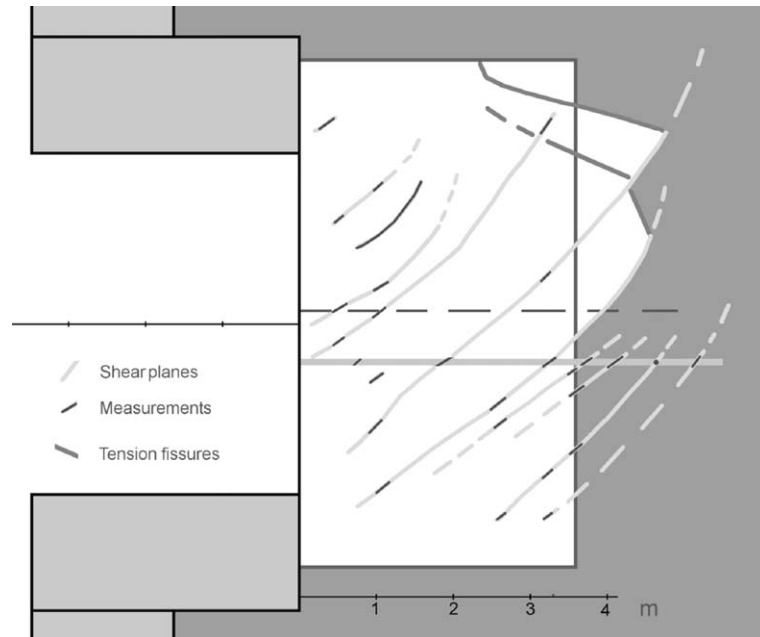
Fig. 10. Vertical cross-section through the Starting and Mounting Chamber. Large fractures (shear planes and tension fissures) are indicated. One can notice that the dip angle of many of the shear planes increases with increasing distance from the second shaft.

Another argument for this theory is the fact that many of the planes become steeper further away from the second shaft (see Fig. 10).

The large tension fissures appeared in the upper third part of the Mounting Chamber (Fig. 10). The strike of the surfaces is on an average perpendicular to

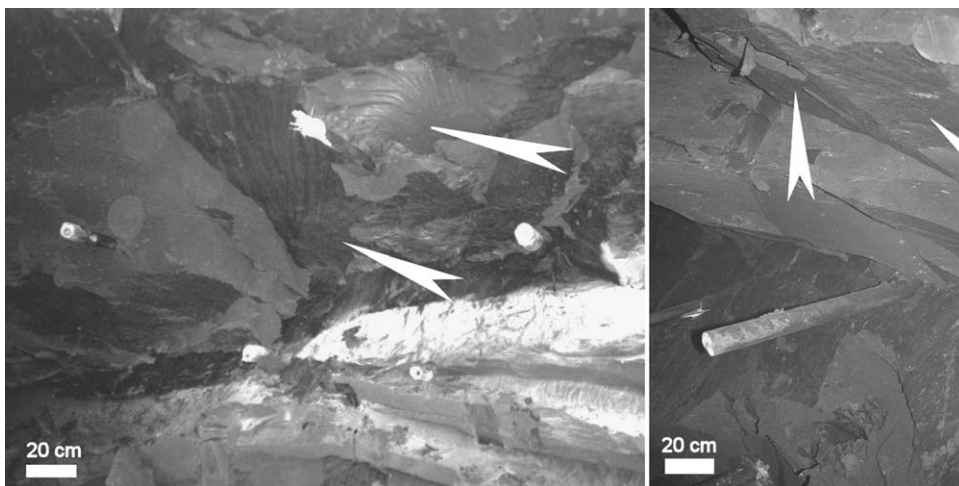
In the upper third part of the excavation, large tension fissures were observed (Fig. 11).

The planes are irregular and seem to consist of several tension fissures which all grew towards each other. The two large planes observed are dipping towards the north. The spacing seems to be the same as the spacing between the large shear planes, i.e. less than 1 m. The different nuclei are visible. The strike of the surfaces is EW on an average. Dip angles are low ( $20\text{--}30^\circ$ ). All fissures are dipping towards the north. Dip decreases towards the roof.

Fig. 11. Picture of large tension fissures. The left picture shows that the fissures consist of several smaller tension fissures which all grew towards each other.

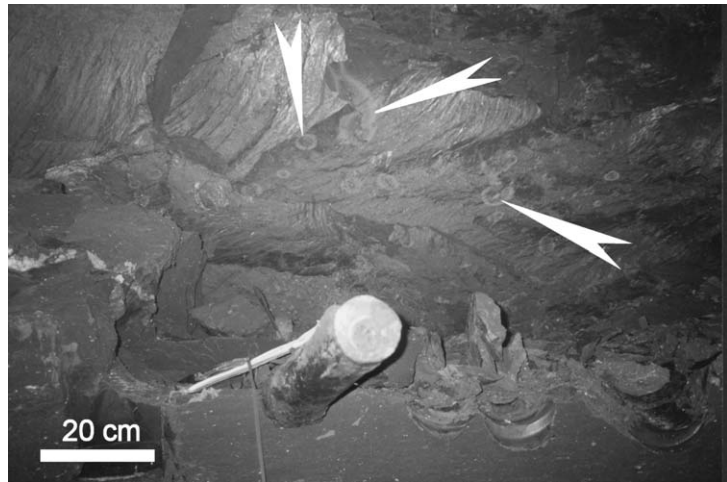
Like the shear planes, these fissures show aperture up to 3 cm. Oxidation occurred till 2 m of depth (Fig. 12).

Fig. 12. Oxidation at a depth of 2 m behind the Starting Chamber. The oxidation marks are formed around small pyrite nodules present in the clay.

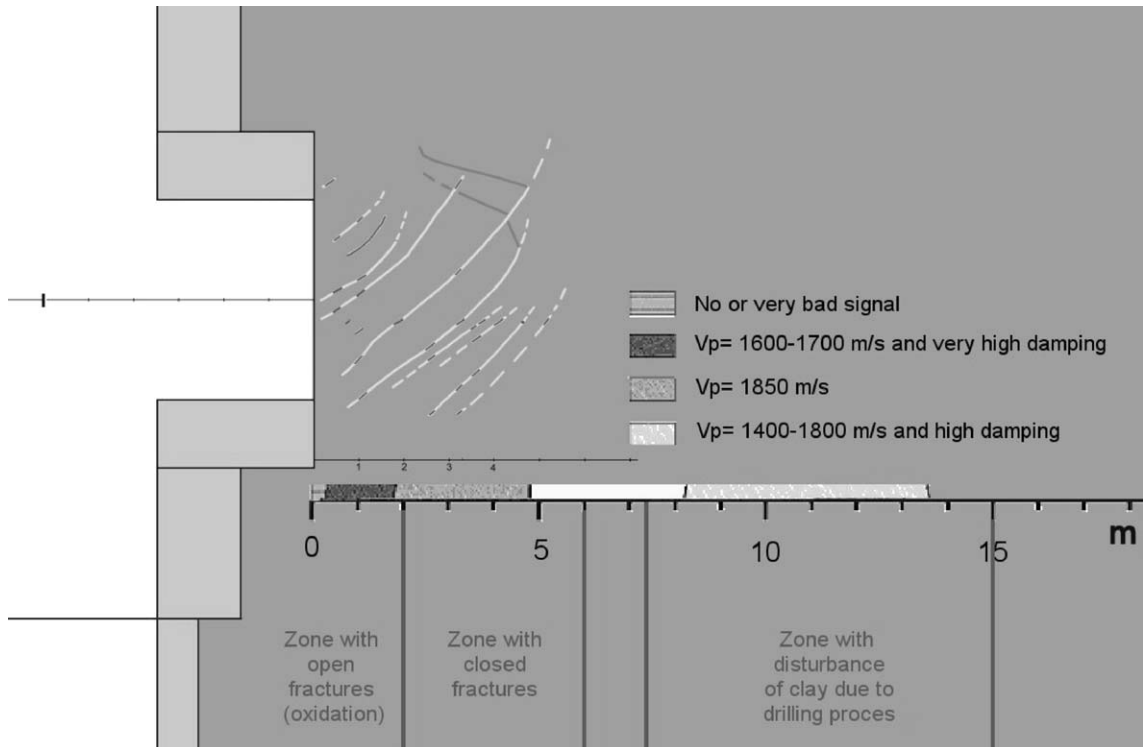
In Fig. 13, the results from the BGR campaign are compared with the observations made in the Mounting Chamber. The area, where a strong attenuation of P-waves was observed up to 2 m of depth, might be explained by the open fractures in the clay mass. The high velocity variations between 8.5 and 13.5 seem to be caused by borehole breakouts and the intense fracturing around the borehole.

Fig. 13. Comparison of all results from the Mounting Chamber. The reconnaissance campaign is compared to the fractures observed during the excavation of the Mounting Chamber.

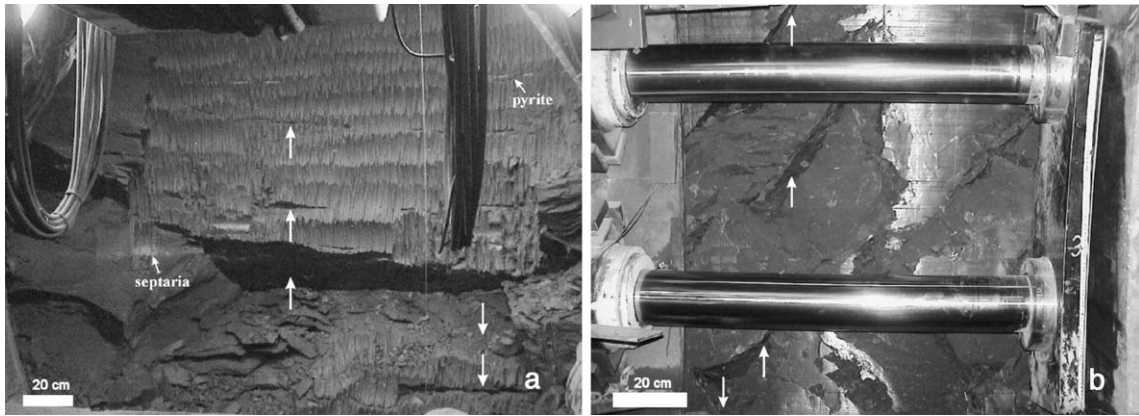
Fig. 14. Pictures of the fracturing in the Connecting Gallery. (a) shows the front. One can see the cross-section of the parallel shear planes, and the intersection is more or less where the block has fallen out. (b) shows a sidewall. The cross-sections of the fractures with the gallery walls were mapped carefully.

curved shape is schematically drawn on a vertical cross-section in Fig. 15. The distance between subsequent fractures is mostly a few decimeters (Fig. 14).

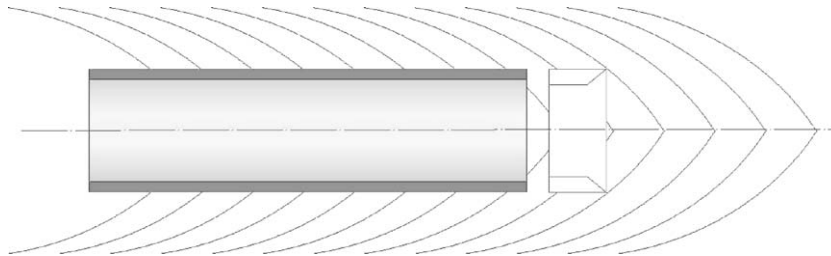
Fig. 15. Schematic representation of a vertical cross-section through the Connecting Gallery showing the typical symmetrical form of the encountered shear planes.

in the upper part, dipping towards the excavation direction (north) and one in the lower part, dipping in the opposite direction (south). The two fracture planes intersected at half the height of the gallery; at this point, their dip is up to 60–70° (N or S) but further away from the axis, in a vertical plane (higher or lower), the dip decreases (values as low as 30° have been measured): the planes are curved. The fracture planes are also curved in the other dimension (horizontal plane): the dip direction is parallel to the gallery axis (~ N–S) near the centre of the face but changes towards the east and west sidewalls. The observed

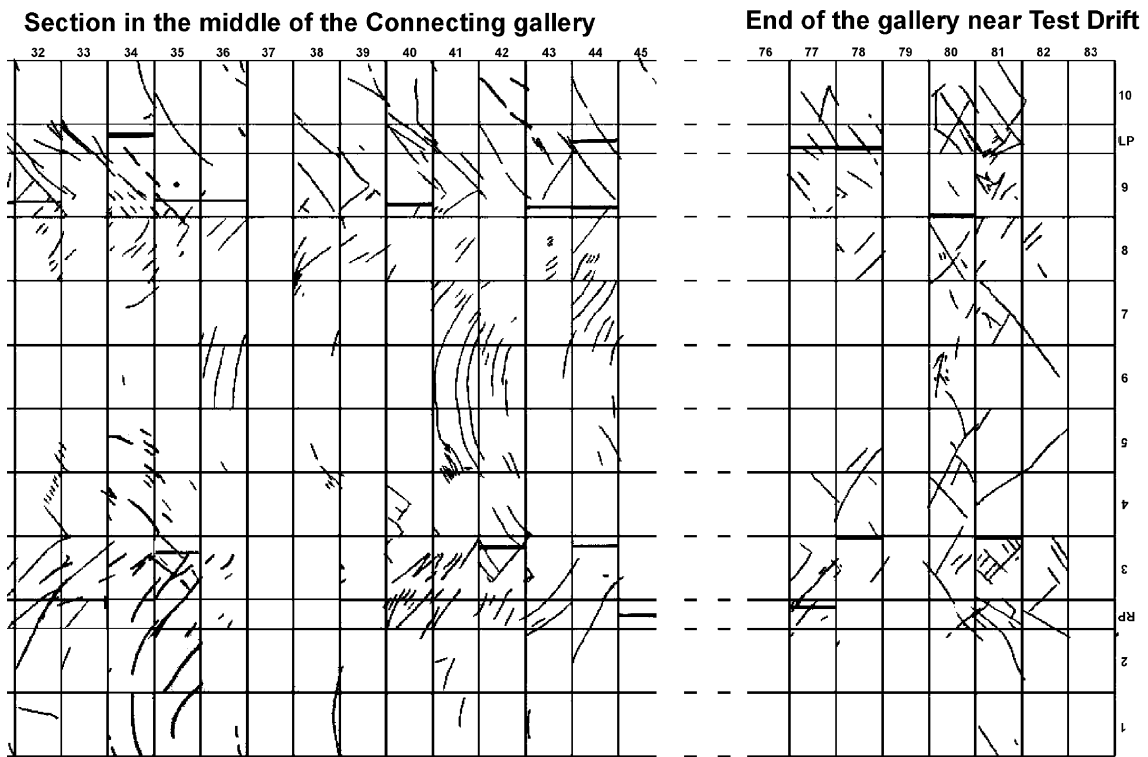
Fig. 17. Unfolded cylinder showing the fracture traces along the walls of the Connecting Gallery. Only two parts are shown here. The left part is representative for the whole gallery, except for the end of it, near the Test Drift. That part is shown on the right side of the figure. One section represents 1 m.

Fig. 17 shows the fracture map of the gallery sidewall; the traces of the fractures are again drawn on an unfolded cylinder (gallery). The width of one wedge-block lining ring is 1 m and as a reference, these lining rings are also indicated on the map.<sup>1</sup> The shape of the traces corresponds with the calculated one (Fig. 18).

Near the connection with the Test-Drift, fractures due to the excavation of the Test-Drift 15 years ago were encountered. Their orientation was consistent with that of the fractures induced by the Connecting Gallery: two fracture planes, dipping towards the south in the upper part and towards the north in the lower part (see Fig. 17).

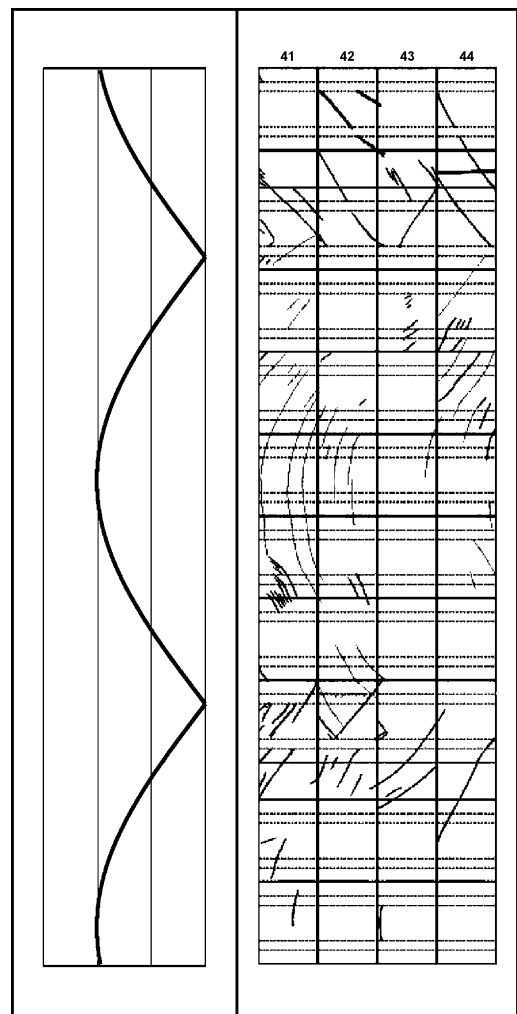
Fig. 18. Comparison between the calculated trace and observed traces along the walls of the Connecting Gallery.

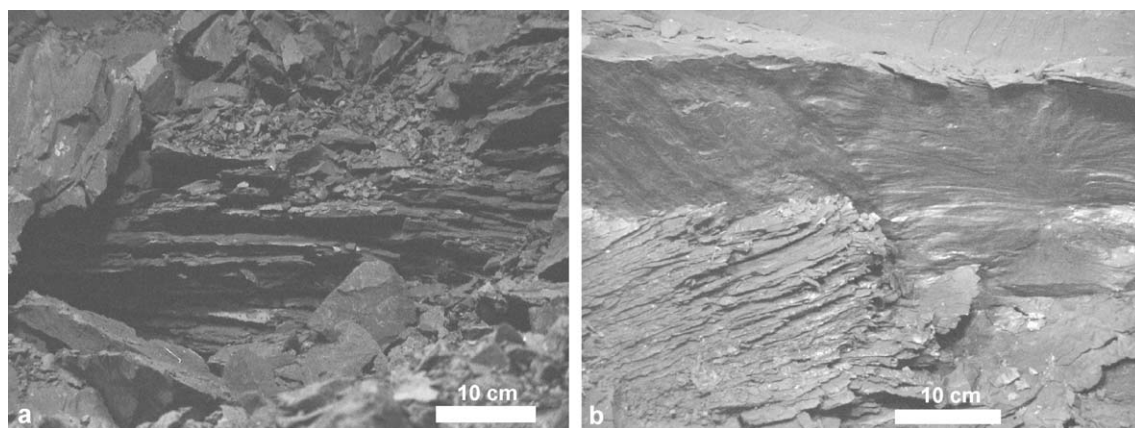
Fig. 19. (a) Fissures due to decompression of the clay. (b) Tension fissures, due to the detachment of clay blocks.

present (see Fig. 7). Other features were encountered as well but they were not systematically studied. For instance, in the lower part of the front, horizontal decompression fissures were observed (Fig. 19a) and large vertical tension fissures were also seen on the face, as a consequence of the detachment of large blocks (Fig. 19b).
