# EURIDICE News

NR. 3

### The OPHELIE mock-up

# THE OPHELIE MOCK-UP

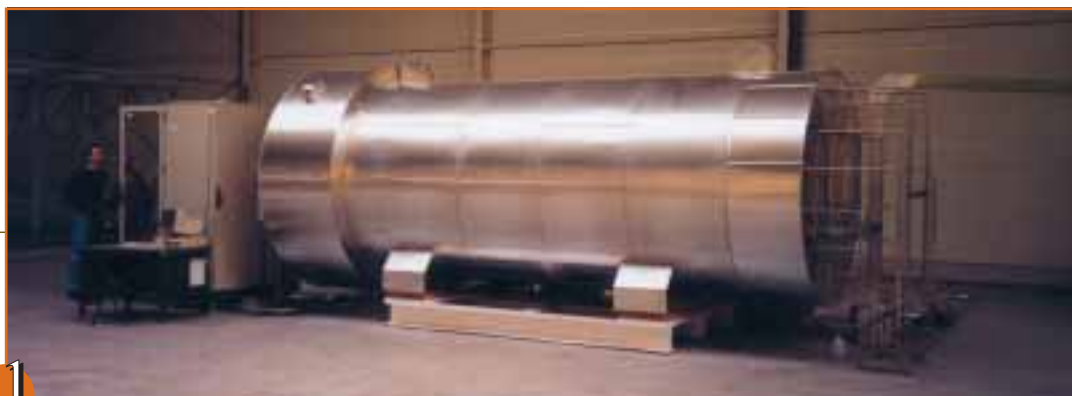
1

Figure 1: the OPHELIE mock-up during operation

In 1995, in preparation for the construction of the pilot gallery, ONDRAF/NIRAS and EIG EURIDICE (named EIG PRACLAY at the time) decided to first operate a large-scale surface test, the OPHELIE mock-up (On-surface Preliminary Heating simulation Experimenting Later Instruments and Equipment – Figure 1).

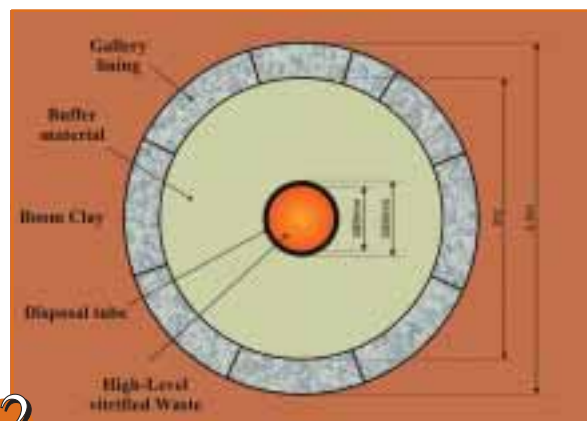
Figure 2: the reference design for heat-emitting vitrified HLW in the mid 90s (cross section of a disposal gallery)

The OPHÉLIE mock-up deals with the reference design valid in the middle of the 90s (Figure 2). In this design, the canisters are placed in a network of horizontal disposal galleries in Boom Clay at a depth of approximately 230 m. Each disposal gallery (2 m internal diameter and 200 or 400 m long), lined with concrete blocks, is first fitted with a metallic disposal tube of about 50 cm external diameter. The space between the disposal tube and the gallery liner is filled with a clay-based buffer material made up of pre-fabricated blocks installed on three concentric rings. Once the buffer material is saturated by water, the waste canisters are pushed into the disposal tube one by one. The heat transfer is thus optimized (good contact between the disposal tube and the buffer material, no remaining voids) when the canisters are installed and, because the buffer material is resaturated and the hydraulic pressure restored, only a limited volume of steam can develop around the disposal tube. Moreover the buffer installation is conducted in a safe environment without radiation and heat.

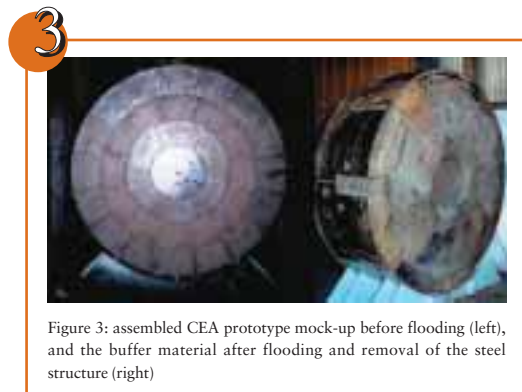
Figure 3: assembled CEA prototype mock-up before flooding (left), and the buffer material after flooding and removal of the steel structure (right)

The whole system was tested in a pre-mock-up at real scale (Figure 3). The test demonstrated that the hydration of the buffer blocks caused a swelling in a few weeks. The most pronounced swelling was that of the external part of the outer ring.

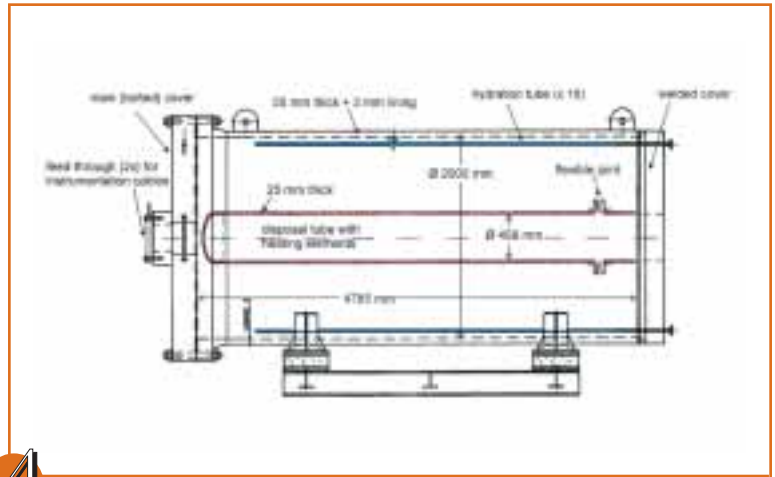
Figure 4: final design of the steel structure of the mock-up

Figure 4 shows the final design of the steel structure of the mock-up. It was dimensioned to withstand a maximum internal pressure of 5 MPa. The fixed extremity of the dummy disposal tube was welded at the backside of the mock-up to a corrugated joint allowing some displacements of the tube. The cover at the front side of the mock-up was bolted after installation of the buffer material and the other inner parts. The instrumentation cables passed through two bundles of press packing on the cover to ensure water tightness. All metallic parts in contact with the buffer were made of stainless steel: AISI 321 for the dummy disposal tube and AISI 316L for the hydration tubes. For the heaviest structures (main cylindrical jacket, backside and front covers), the carbon steel was protected against corrosion by means of a 3 mm thick AISI 304 stainless steel cladding.

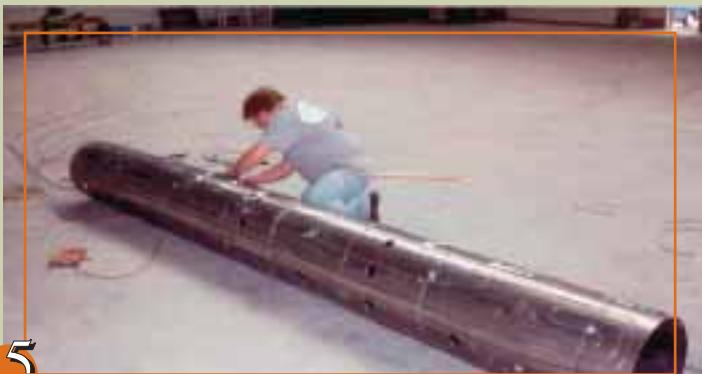
5

Figure 5: the heater during assembly

A linear heat output of  $450 \text{ W}\cdot\text{m}^{-1}$  was imposed by the heater (Figure 5) placed inside the dummy disposal tube. This value is higher than the actual heat output of the waste forms (around  $350 \text{ W}\cdot\text{m}^{-1}$ ), to compensate for the limited duration of the experiment. A constant temperature was maintained at the extrados of the mock-up using heat tracing cables and an external thermal insulation. Scoping calculations performed during the preparation of the experiments indicated a maximum temperature of  $120 \text{ }^\circ\text{C}$  at the interface between the buffer and the intrados of the steel structure.

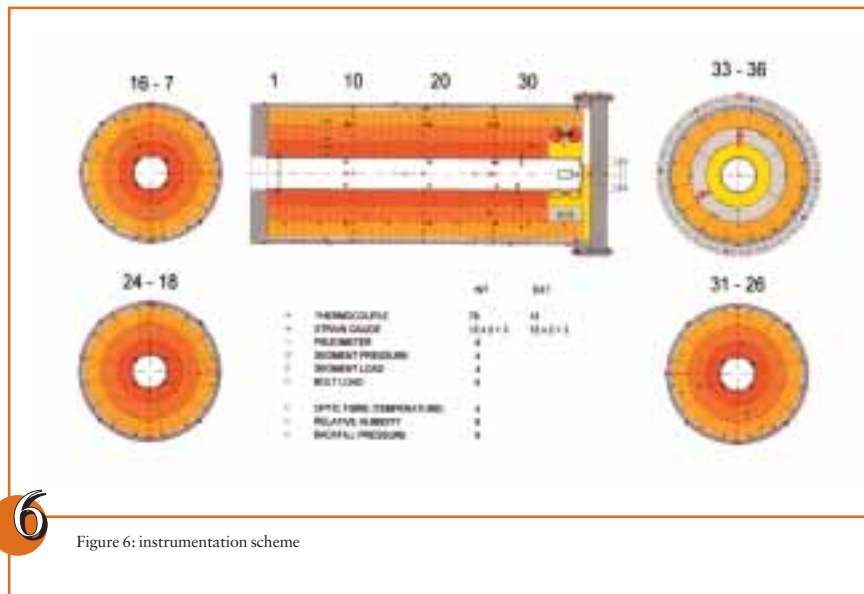
Figure 6: instrumentation scheme

The instruments consisted mainly of temperature sensors and strain gauges, completed with pore pressure sensors, moisture sensors, and total pressure cells (Figure 6). Both the disposal tube and the outer steel liner were instrumented with 27 strain gauges each. The strain gauges on the outer liner transformed this structure into one large swelling pressure sensor, while the gauges on the disposal tube were intended to detect possible mechanical anomalies due, e.g., to a non-uniform swelling. The buffer material was instrumented with 78 thermocouples, 6 pore pressure sensors, 9 total pressure cells, and 9 relative humidity cells. These sensors were installed to follow the hydration, the swelling, and the heating of the buffer material.

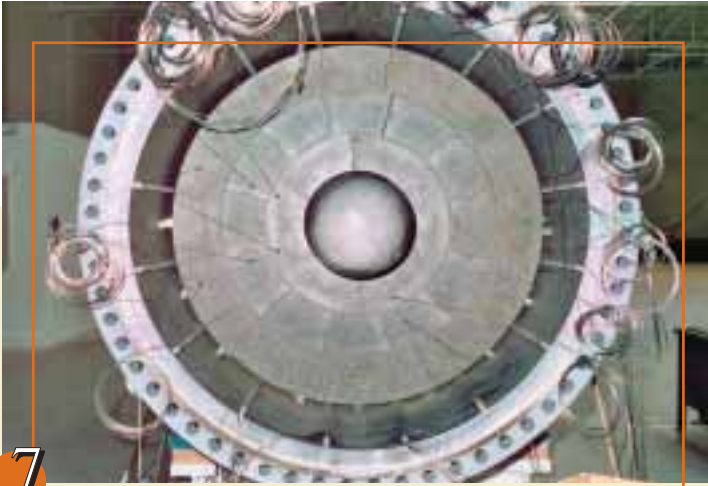
7

Figure 7: assembly of the mock-up with the three buffer rings, sensor cables, and hydration tubes

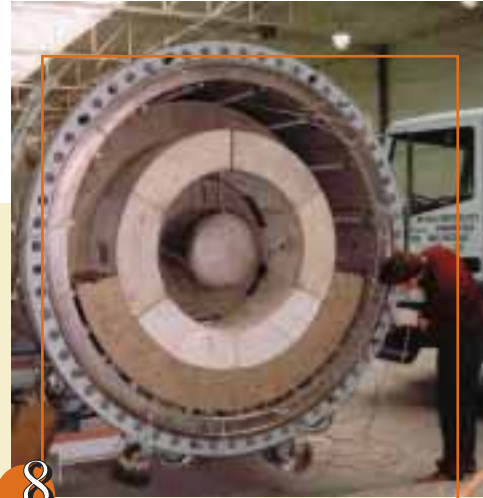
8

Figure 8: view of the concrete segment and clay-enriched blocks at the extremity of the buffer set-up near the front cover

The final 0.50 m near the cover had a different structure (Figure 8): the middle ring was replaced by a ring of six concrete segments to test total pressure cells and load cells. The inside of the ring was filled with sand as inert material. To compensate the absence of swelling of concrete and sand, the outer ring was made up of clay-enriched blocks (85 wt % of FoCa Clay compared to 60 wt % in the other rings). Each of

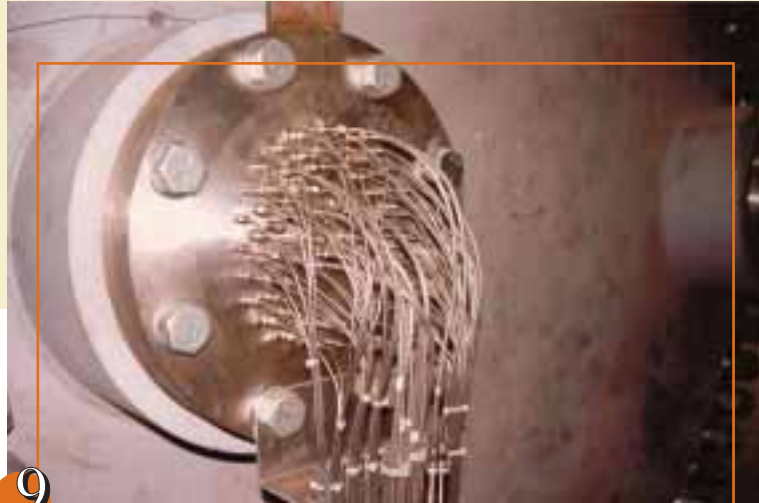
9

Figure 9: hermetic sealing of the sensor cables

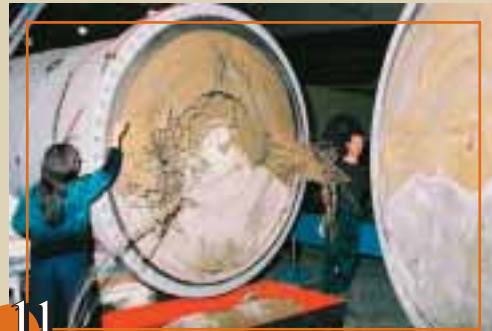
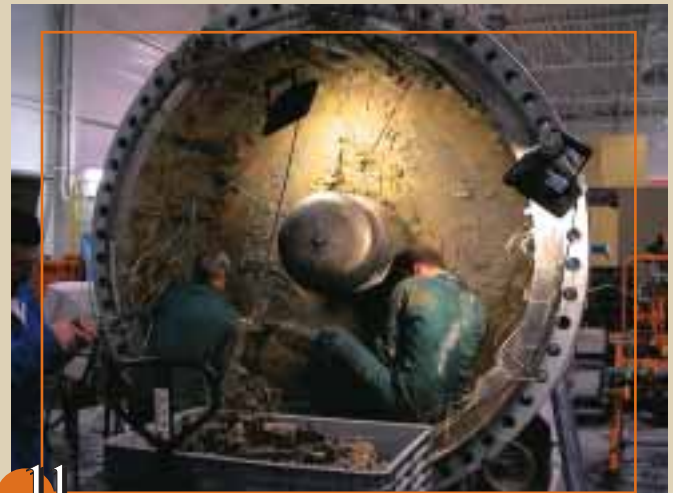
11

Figures 11: dismantling activities. The movement of sand (white zone) could be observed after removal of the cover (above). Dismantling tasks (below)

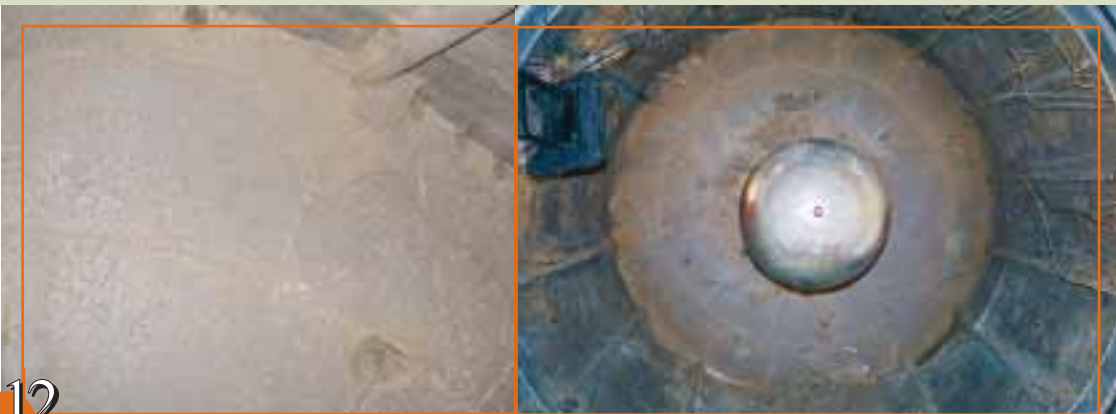
12

Figures 12: the buffer material filled all technical voids but the joints between blocks were still visible

The observations made during the dismantling showed that the buffer material had filled by swelling all the technological voids, in particular the technological annular space initially present at the periphery of the buffer near the hydration tubes. Such swelling is favourable to limit the microbial activity and the corrosion of the disposal tube. Though all three concentric rings swelled, generating a radial displacement of the bentonite blocks, the swelling mainly occurred at the external ring because of the presence of the large initial annular space. The swelling process was thus non homogeneous. It was also still possible to identify the blocks and the joints between them (Figures 12). With some extra precautions during the dismantling operations, most of the bentonite blocks of the inner and the medium rings could even have been recovered nearly intact.

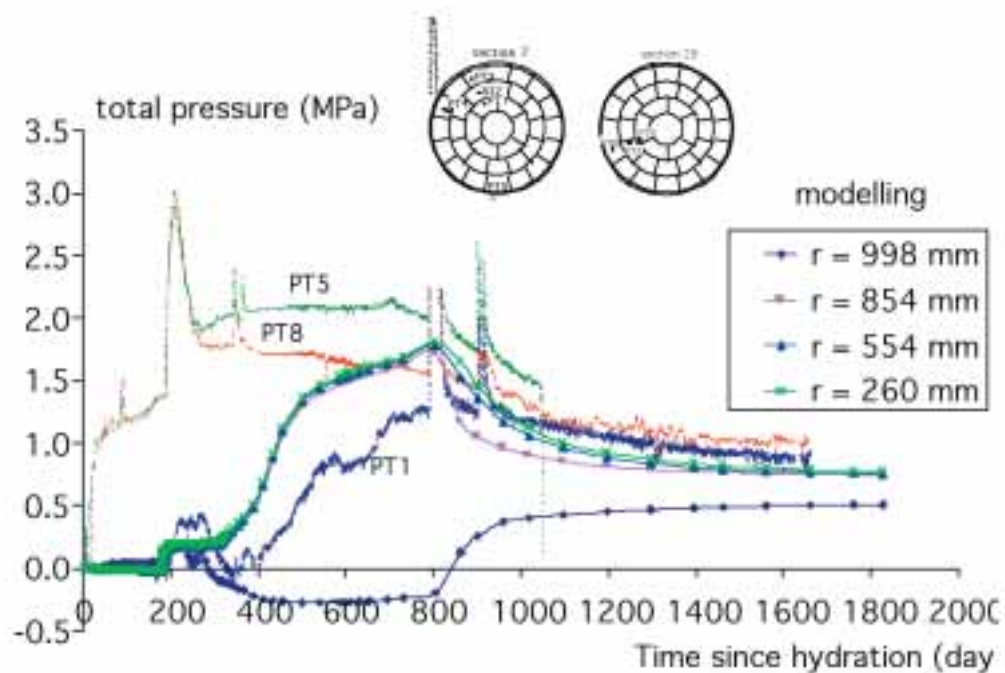
Figure 13: evolution of the total pressure: comparison between experimental data and simulation results (bolted lines)

The swelling pressure generated in the mock-up was lower than expected, and decreased with time after reaching a maximum value. The swelling pressure values were comprised between 1.5 and 2 MPa, without considering the peaks due to artificial undrained heating events, while a value of 4 MPa was expected.

The evolution of the swelling pressure cannot be explained only by the average density of the buffer in the mock-up (for the development of the buffer material, the initial technological voids were averaged over the whole mock-up). The generation of the swelling pressure in the mock-up depended not only on the THM boundary conditions of the mock-up, but also highly on the THM behaviour of the buffer itself. One of the most important findings of the extended laboratory tests is indeed that the material presents a much lower “plasticity yielding” stress upon hydration, heating and loading. Another aspect is that the material presents a small potential of “collapse” (reorganisation of the micro-structure which may induce a decrease of the stress) upon hydration when approaching saturation. Numerical simulations using the parameters derived from the extended laboratory THM characterisation programme reproduced fairly well the observed evolution of the swelling pressure (Figure 13).

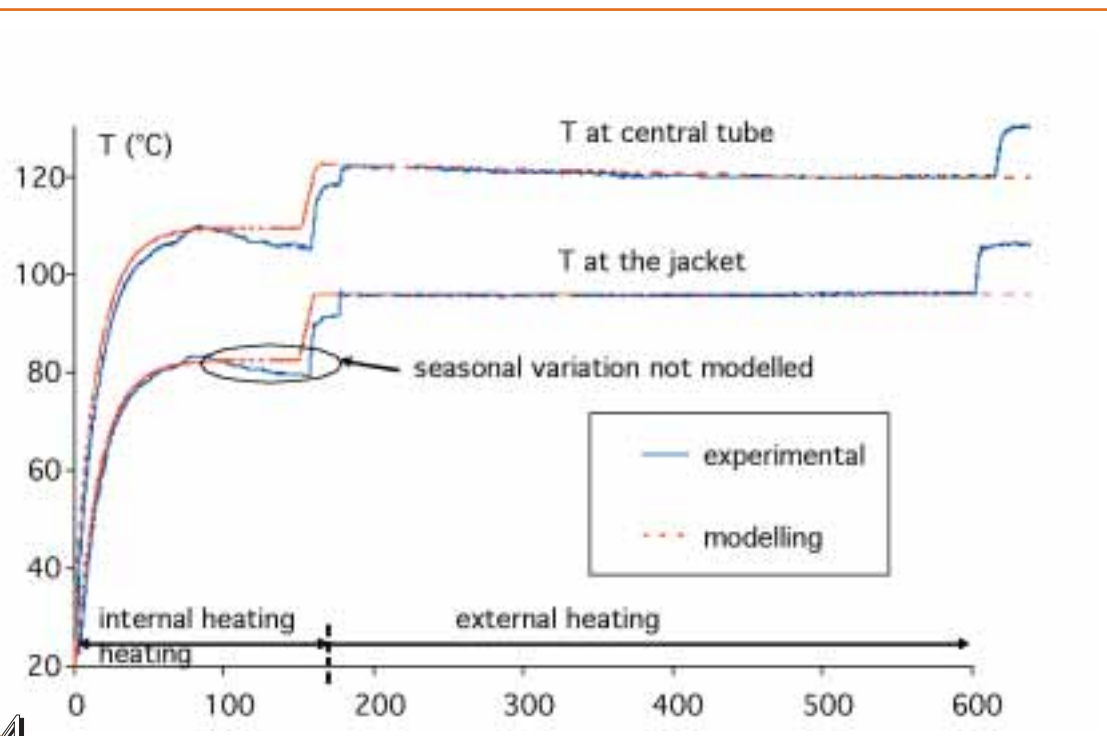
Figure 14: evolutions of the temperature close to the external liner and to the disposal tube: comparison between experimental data and simulation results. Only the evolution during the first 600 days - where the main heat transfer mechanism appeared - is simulated here

During the operational stage, an unexpected observation was made: the temperature profiles revealed an apparently enhanced heat transfer mechanism. A value as high as  $4.5 \text{ W}\cdot\text{m}^{-1}\cdot\text{K}^{-1}$  for the thermal conductivity was derived on the basis of the temperature gradient between the dummy disposal tube and the external jacket and considering a heat power of  $450 \text{ W}\cdot\text{m}^{-1}$  and only conduction transfer mechanism. To explain the apparent high value of the thermal conductivity, a series of one-dimensional numerical simulations based on the THM properties obtained from the laboratory tests were carried out. Numerical results showed that, for such a material, the heat transfer is dominated by conduction. Other modes of heat transfer are insignificant: there are no evident effects on the radial temperature gradient. A detailed analysis of the temperature measurements at different components of the mock-up suggested that the high apparent thermal conductivity resulted mainly from the “loss of heat” through different components in different directions. Temperature measurements revealed that the hydration tubes and the two covers of the mock-up constituted the main sources of the heat loss, despite their isolation. A loss of as much as 15 to 18 % of heat was assessed. Moreover, the fact that the thermal conductivity increases with saturation played an important role in the observed temperature profiles in spite of its intrinsically high value. Taking into account the above-mentioned factors, the temperature evolution in the mock-up can be reproduced reasonably well by the simulations (Figure 14).

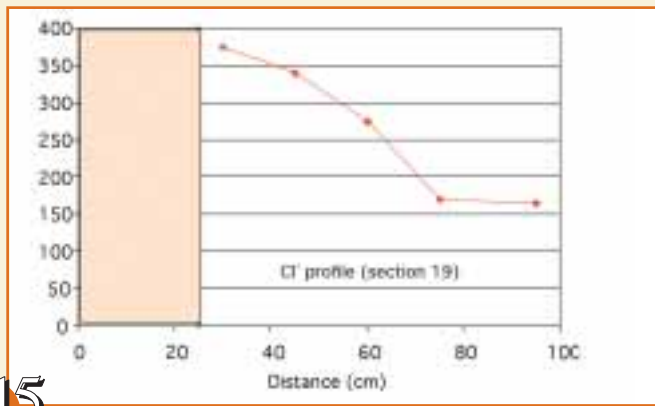
15

Figure 15: enrichment of chlorides towards the disposal tube

Chemical analyses of water from the leaks revealed a relatively high concentration of chloride ( $1 \text{ g}\cdot\text{dm}^{-3}$  instead of  $0.1 \text{ g}\cdot\text{dm}^{-3}$  expected for FoCa Clay water) originating from the buffer material itself. The concentration of other species (e.g., dissolved organic carbon, dissolved silica, or nitrates) was also higher than expected. Chemical analyses of major elements in water squeezed out from the exposed buffer material sampled during the dismantling later confirmed a process of enrichment of some solutes towards the disposal tube (Figure 15). At least two mechanisms could explain such enrichment:

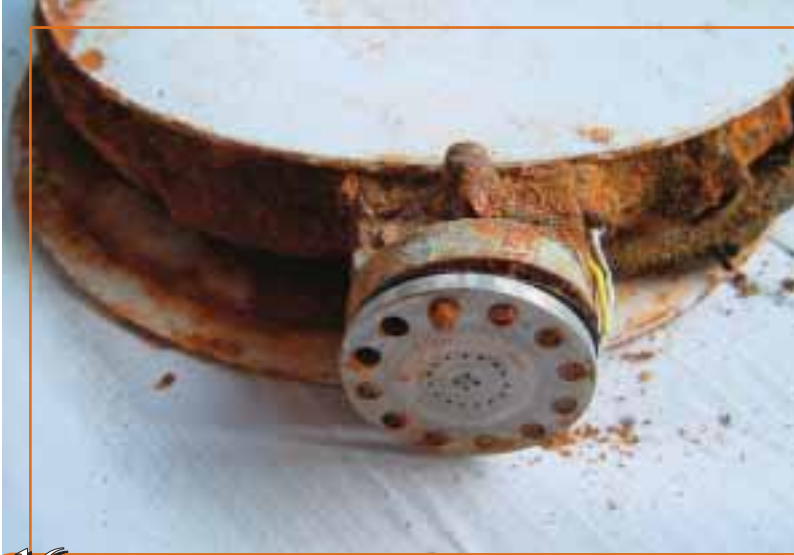
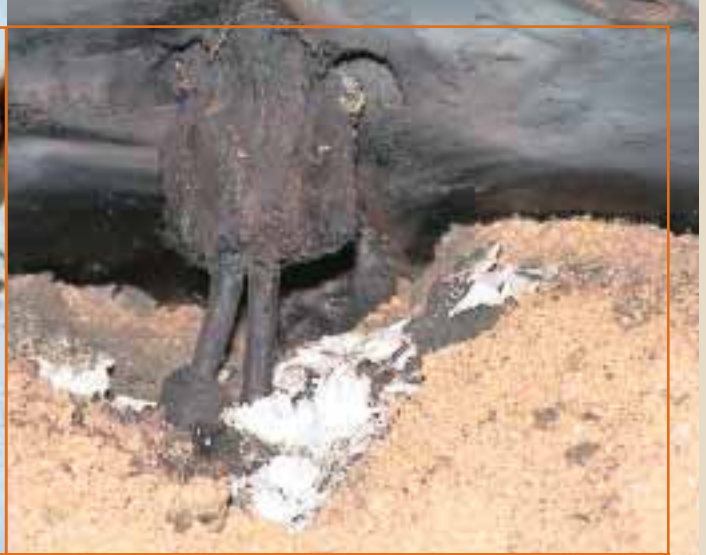
16

Figures 16: severely corroded Glötzl cells responsible for the release of hydrocarbons in the pore water of the buffer material

observed microbial activity. Its source still remains unclear: organic matter naturally present in the FoCa Clay or a contamination by hydrocarbons (mixture of gasoline and oil) released by defective Glötzl cells used for total pressure measurements (Figures 16). These cells appeared to have been severely damaged by a corrosion problem caused by an inappropriate choice of the metal of their envelopes.

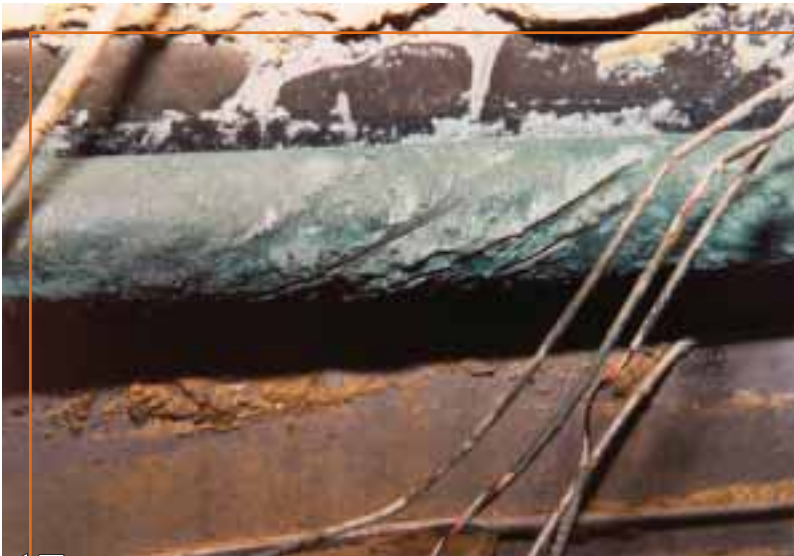
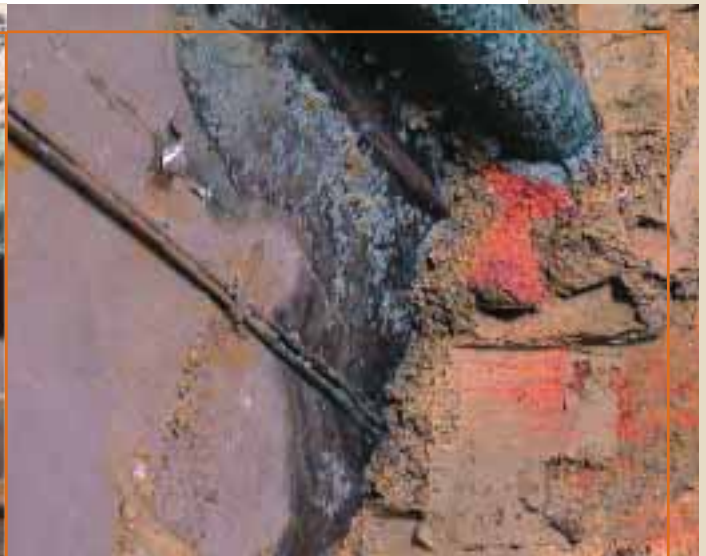
17

Figures 17: galvanic or electrolytic corrosion on the total length of hydration tube # 07

The most striking observation dealing with corrosion in the mock-up was certainly the general corrosion of hydration tube # 07 exhibiting a green crust containing Cr<sup>3+</sup> oxides (Figure 17). A failed relative humidity sensor was discovered not far from this tube and it is very probable that the electrolysis induced by a direct current applied to this sensor during 5 years caused this very spectacular corrosion.
