SEALING/HEALING in Argillaceous Media: Laboratory Tests Results

CEN • SCK

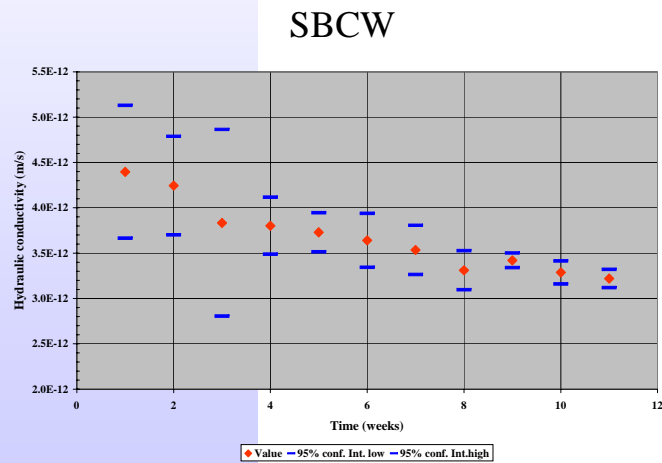
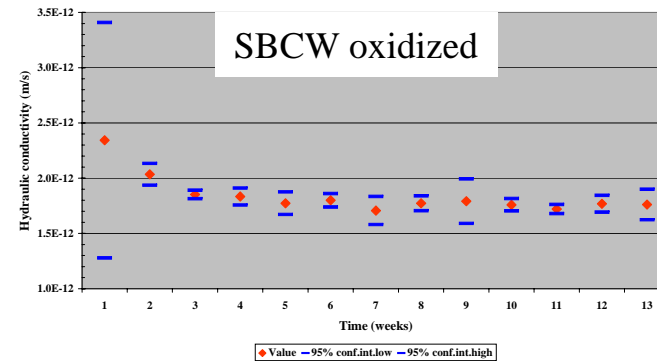
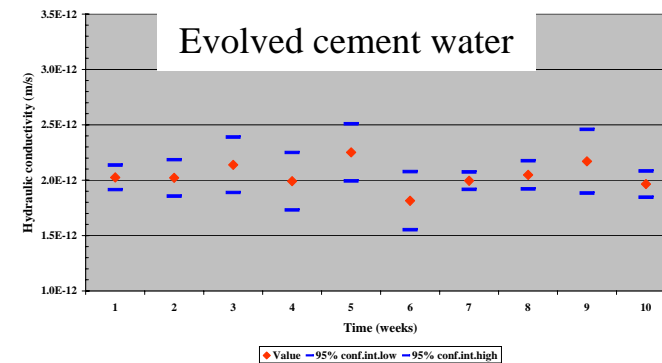
Permeameter Cell Tests: Boom Clay (1)

- A slow self-sealing is observed when SBCW in normal and oxidized condition is injected
- A fast self-sealing is observed when evolved cement water is injected

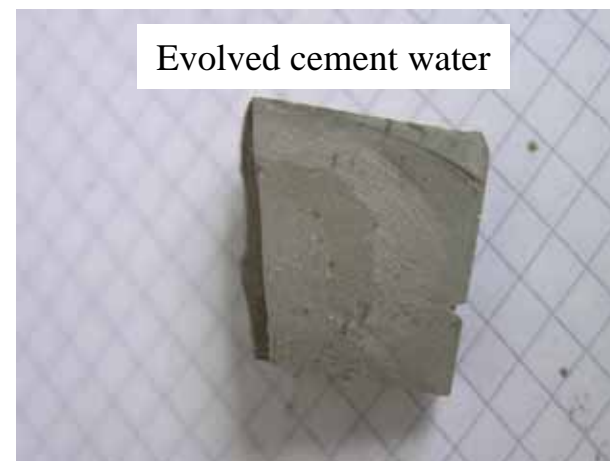
Permeameter Cell Tests: Boom Clay (2)

- Though the hydraulic properties seem to be restored, the mechanical properties are not. The best cohesion is obtained with the injection of evolved cement water. SEM micrographs show only clay minerals present in the original fracture: no cementation (cf presentation M. Van Geet together with μ CT scans)

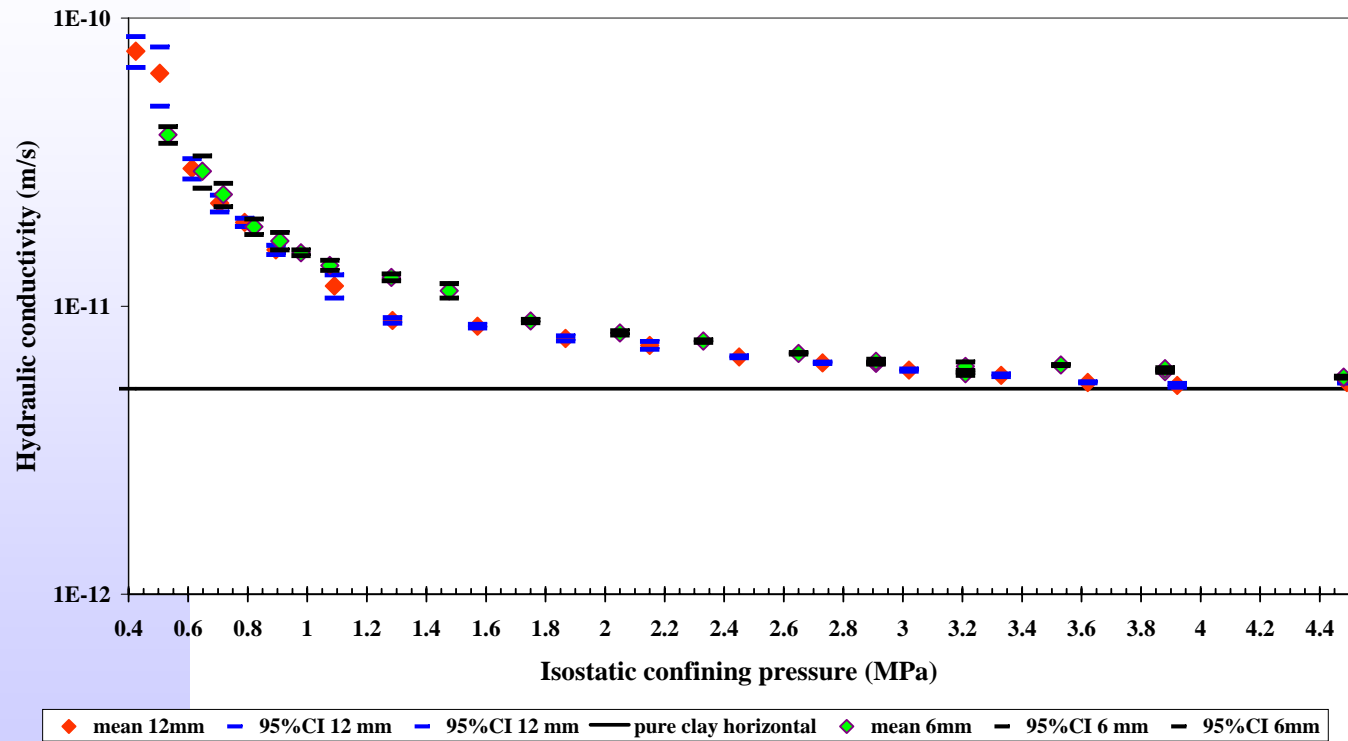
Hydraulic Conductivity Evolution of the Boom Clay Samples is similar

Evolution of the hydraulic conductivity in BC sample

- Two tests have been carried out on Boom Clay samples
 - Same original core
 - 6 and 12 mm centered drillhole at the installation
 - SBCW injected through the bottom of the sample (flow parallel to the orientation of the bedding plane)
 - The confining pressure is progressively incremented (starting at 0.1 MPa g) up to a final value of 4.5 MPa while the mean effective stress and mean pore water pressure are kept equivalent
 - The evolution of the hydraulic conductivity and of the consolidation are monitored

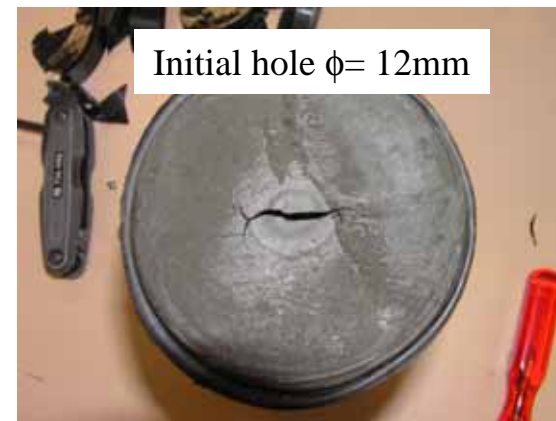
Pictures of the Samples Taken after the Dismantling Operation

- The decompression of the samples during the dismantling operation provoked the formation of a fissure throughout the sample in its centre en oriented in a // direction vs. The bedding plane
- Fissure dimension correlated with the initial hole dimension
- Discharge rate sample with initial 6mm hole: 5 hours
- Discharge rate sample with initial 12mm hole: 1 week

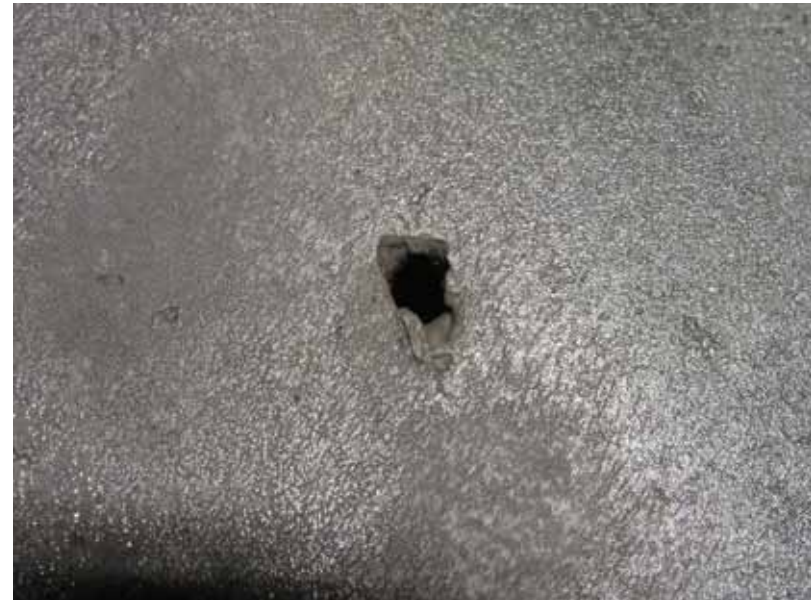
No sealing observed for the sample with the larger hole diameter (4mm)

- The hole was still present when the sample was dismantled with similar dimensions as when installed. A direct connection between the sample boundaries could be established by permeability pulse tests and confirmed visually and by μ CT scans

- Two tests have been carried out on Opalinus Clay samples
 - Same original core
 - 2.5 and 4 mm centered drillhole at the installation
 - Low saline Pearson water injected through the bottom of the sample (flow parallel to the orientation of the bedding plane)
 - The confining pressure is progressively incremented (starting at 0.1 MPa g) up to a final value of 4.5 MPa while the mean effective stress and mean pore water pressure are kept equivalent
 - The evolution of the hydraulic conductivity and of the consolidation are monitored

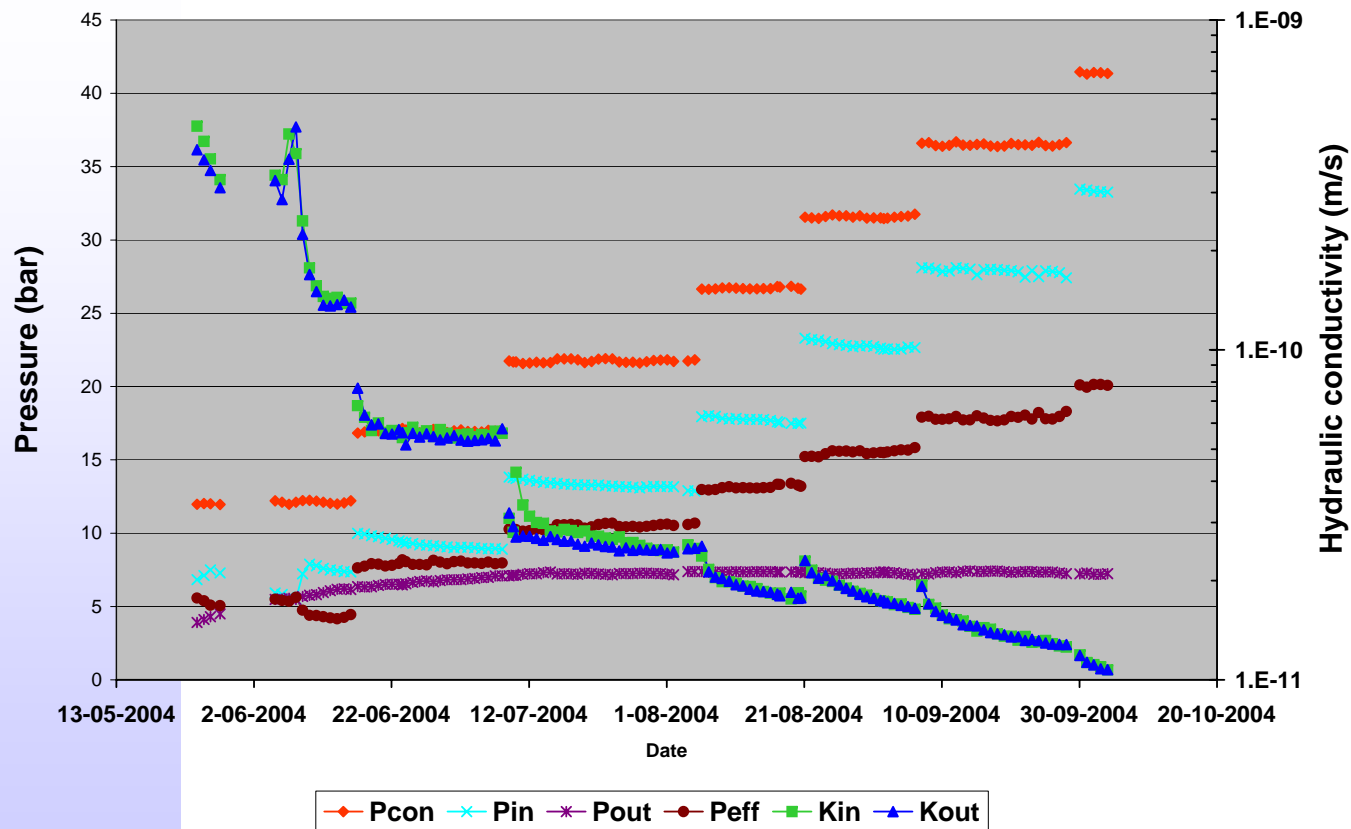
A Moderate Sealing Process could be Detected for the Sample with the Smaller Hole Diameter (2.5mm)
