The OPHELIE mock-up

Final report

Foreword and summary

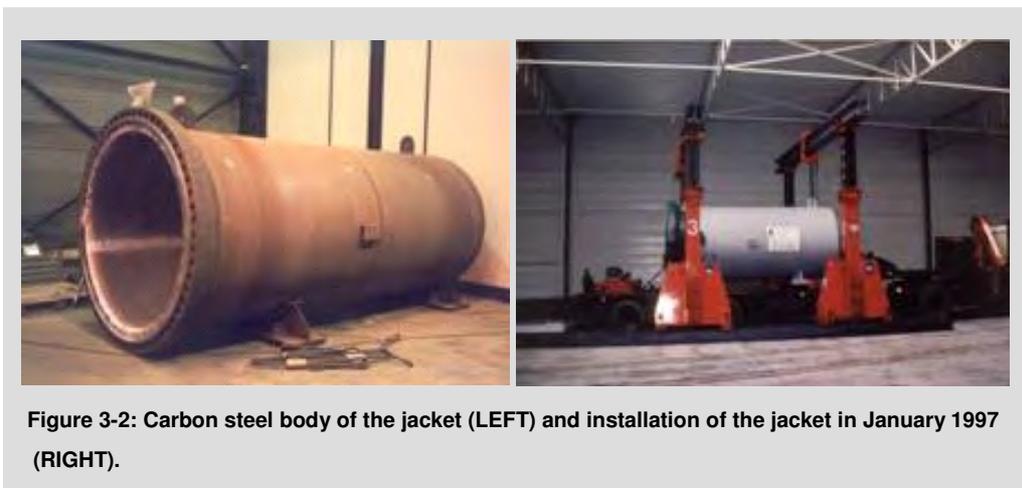
Figure 3-2: Carbon steel body of the jacket (LEFT) and installation of the jacket in January 1997 (RIGHT).

The actual installation of the steel jacket took place at the end of January 1997 (Figure 3-2, RIGHT).

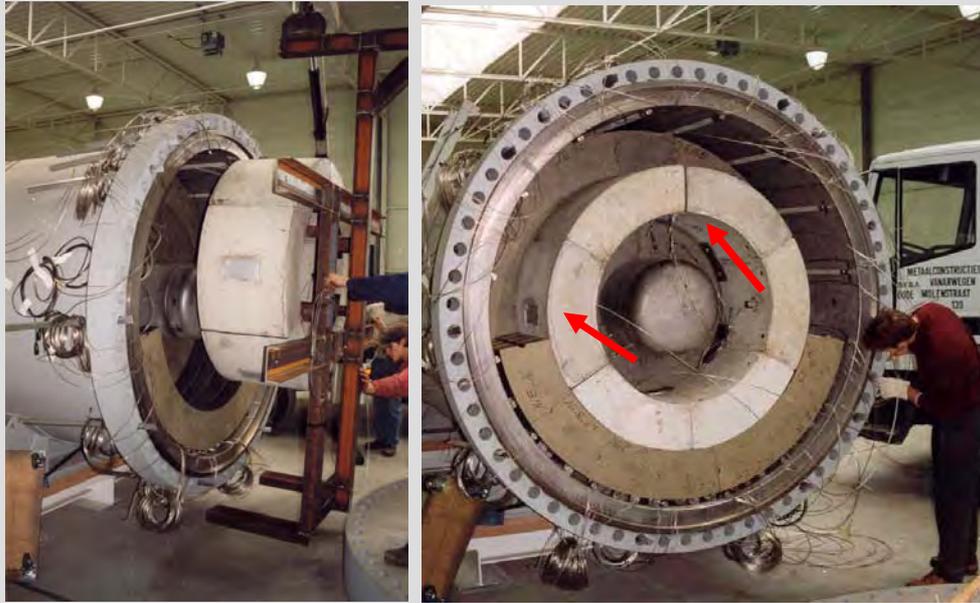
Figure 3-6: Installation of the concrete ring (LEFT) and concrete ring after placement partially surrounded by M14 buffer blocks (RIGHT). An extrados pressure cell is mounted, and at the top interface, two load cells are installed between the segments.

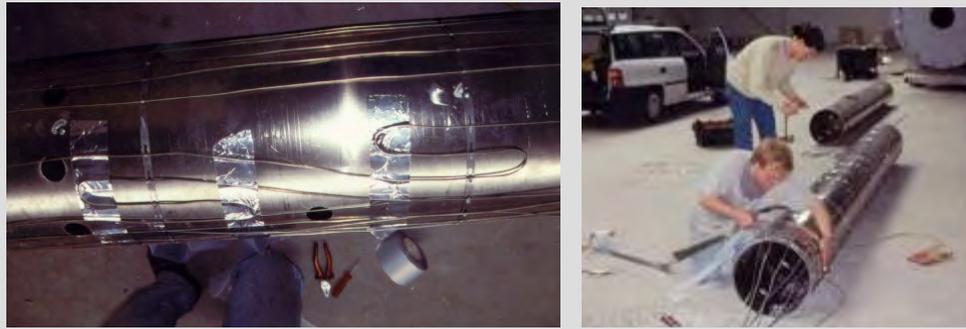
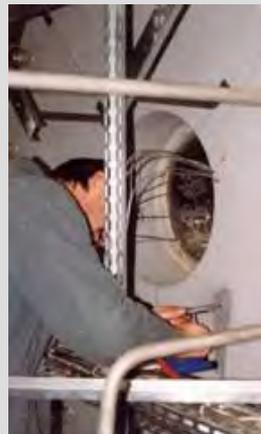
Figure 3-7: Installation of the heater cables on the extrados of the inner aluminium tube (TOP). The inner aluminium tube was then inserted in an outer aluminium tube to protect the heating cables. These two aluminium tubes were then inserted inside the central tube (BOTTOM).

ISOPAD GmbH supplied the heating cables, based on the study performed for the PRACLAY Experiment in 1995. The cables (model KMV-6), each 40 m long, consisted of a NiCr core (Cu for the cold part of the cable), insulated by MgO powder and enclosed in a stainless steel sheath with an outer diameter of 3.5 mm.

The cables were installed on the extrados of an aluminium tube (438 mm diameter and 4 565 mm long, made from 3 mm thick aluminium sheet, Figure 3-7), and covered by a second outer aluminium pipe (450 mm diameter, same length). Along with the heating cables, 6 thermocouples were also installed to monitor local temperatures inside the heater assembly. The whole assembly was then pushed into the central tube.

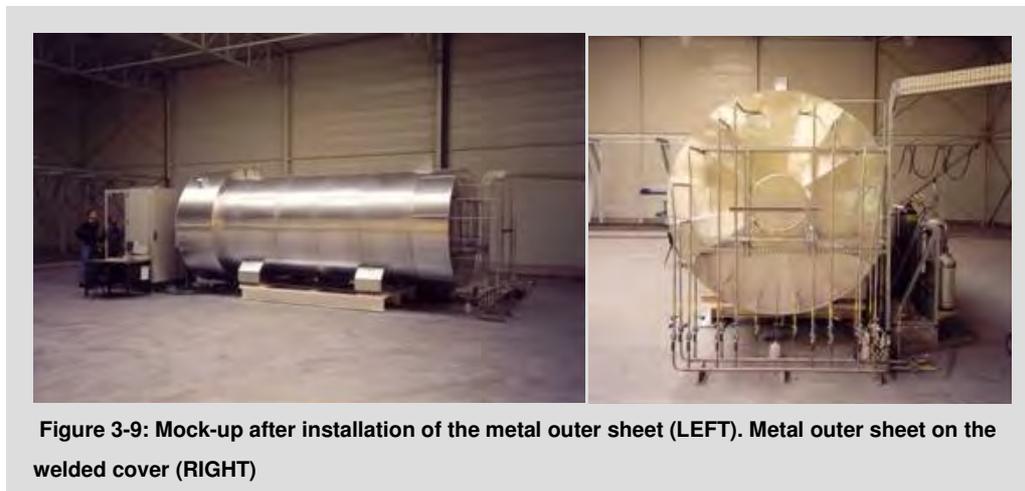
Figure 3-9: Mock-up after installation of the metal outer sheet (LEFT). Metal outer sheet on the welded cover (RIGHT)

To obtain a radial heat flow, the axial heat flow was limited as much as possible. In thermal simulations, adiabatic conditions were assumed at the covers. By applying thick thermal insulation (300 mm of Rockwool) heat loss at the covers was kept to a minimum. The insulation was installed by the Hertel Company in January 1998 (shortly after the hydration phase had started). The Rockwool insulation was finished with a metal outer sheet (Figure 3-9).

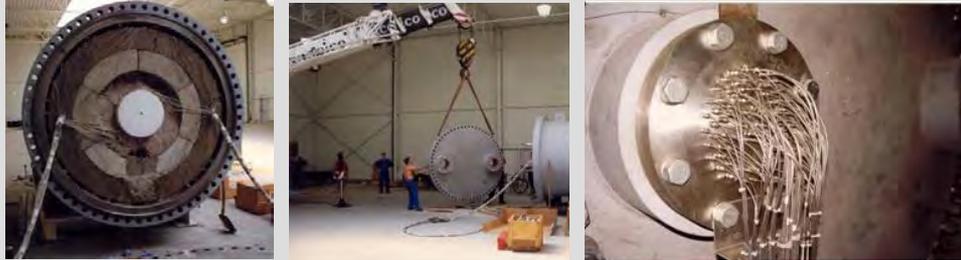
Figure 3-10: The mock-up just before the installation of the bolted cover (TOP). The volume between the concrete segments and the central tube was filled with sand type SIBELCO M32. The white piece is the PTFE protecting the hemispherical end of the central tube. Installation of the bolted cover (BOTTOM LEFT). About 80 instrumentation cables and tubes were fed through each of the two instrumentation covers (BOTTOM RIGHT).

- the filling of the volume between the concrete segments and the central tube with SIBELCO M32 type sand (Figure 3-10, TOP);
- installation of the bolted cover (Figure 3-10, BOTTOM LEFT);
- connection of the 16 hydration tubes to the external equipment of the hydration system;
- passing of the instrumentation cables through the instrumentation covers (Figure 3-10, BOTTOM RIGHT), and connection to the data acquisition system;
- installation of the external strain gauges and thermocouples;
- installation of the internal heating system;

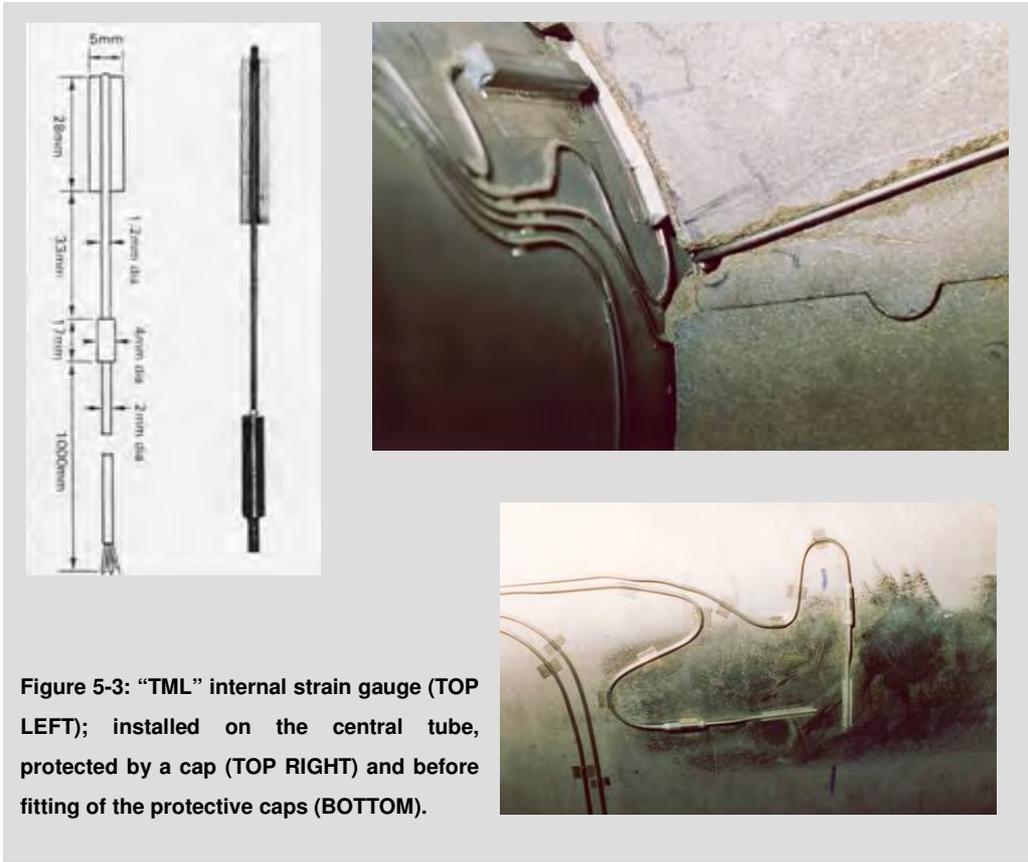
Figure 5-3: "TML" internal strain gauge (TOP LEFT); installed on the central tube, protected by a cap (TOP RIGHT) and before fitting of the protective caps (BOTTOM).

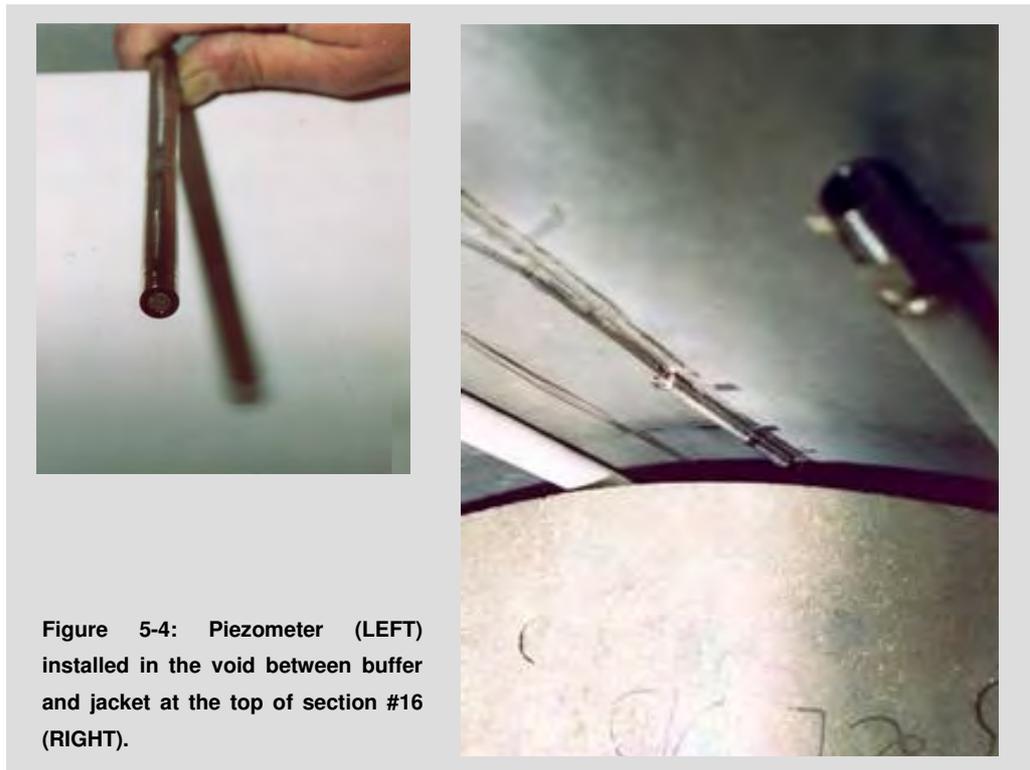
Figure 5-4: Piezometer (LEFT) installed in the void between buffer and jacket at the top of section #16 (RIGHT).

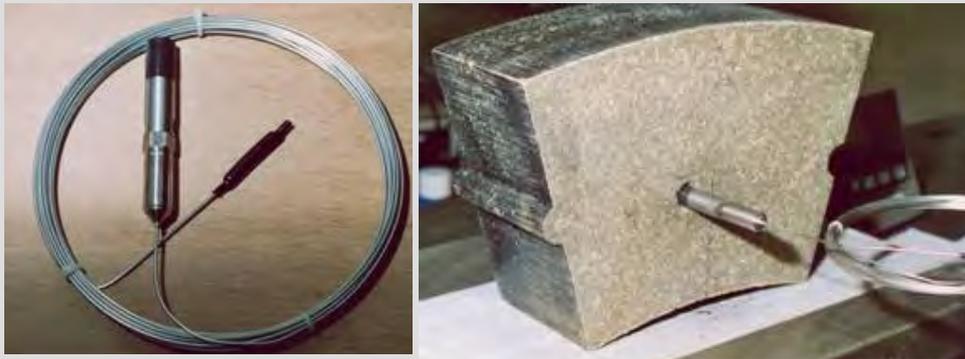
Figure 5-5: Total pressure sensor (LEFT); installed in hole in the buffer block (RIGHT).

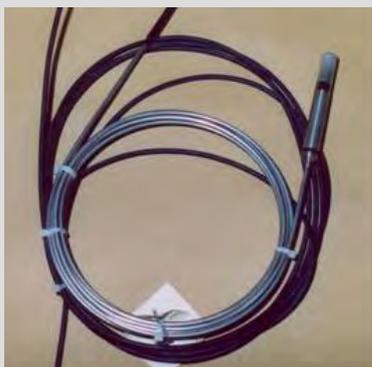
Figure 5-6: Relative humidity sensor with cap and stainless steel cable sheath (extended with flexible cable).

To measure the hydration of the buffer, relative humidity cells from Rotronic (CH), model Hygromer I-400, were adapted by CEA for installation in the buffer (Figure 5-6). These sensors had to measure the relative humidity in the buffer pockets formed by a sintered stainless steel filter cap. CEA had established a relationship between the moisture content of the buffer and the relative humidity in the pores. The original signal cable was replaced by a stainless steel sheathed cable (7-conductor), and this cable carried the signal from the capacitive measuring element and the Pt100 temperature sensor. The sensors were placed in predrilled holes in the blocks; due to their length, each sensor needed a hole drilled in two consecutive blocks. An external processing unit conditioned these signals into two 4-20 mA signals.

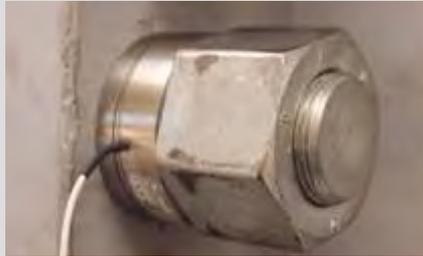
Figure 5-7: Bolt load cell to monitor the load increase due to the buffer swelling.

installation (Verstricht, 1996). The bolt load cells consisted of ring-shaped load cells to measure the bolt load (Figure 5-7), both of the pre-stress applied during fastening and load development due to swelling of the buffer material.

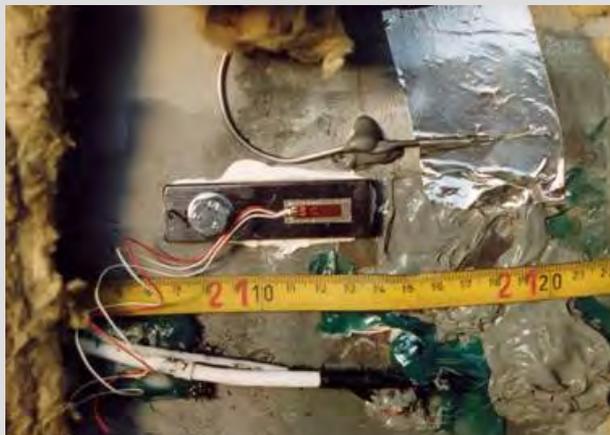
Figure 5-8: External strain gauges, with dummy gauge mounted on separate carrier.

On the outside of the jacket, 27 strain gauges were installed in a configuration similar to the central tube. Conventional foil strain gauges, pre-mounted on a metal (Inconel) carrier were chosen, which could be installed by spot-welding to the mock-up jacket. In May 1998, after the first measurements were analysed, the dummy gauges (for thermal compensation) were replaced by an improved set-up with separate steel carriers (Figure 5-8).

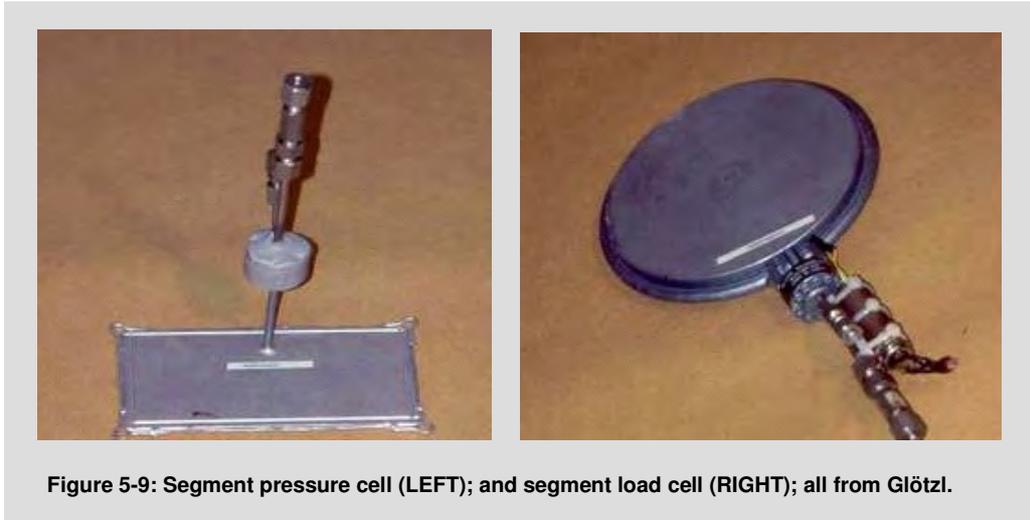
Figure 5-9: Segment pressure cell (LEFT); and segment load cell (RIGHT); all from Glötzl.

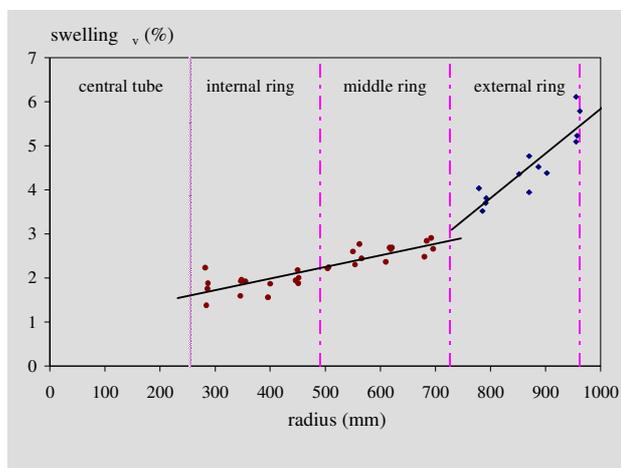
Figure 7-2 : Increase of the block volume through swelling.

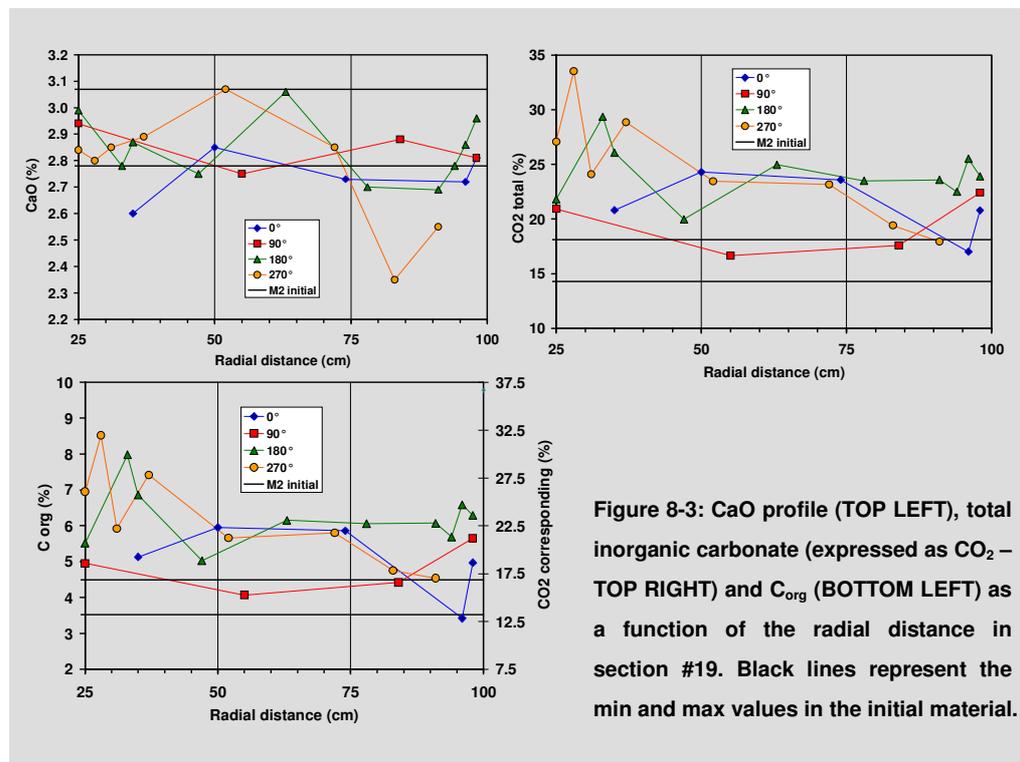
Figure 8-3: CaO profile (TOP LEFT), total inorganic carbonate (expressed as CO_2 – TOP RIGHT) and C_{org} (BOTTOM LEFT) as a function of the radial distance in section #19. Black lines represent the min and max values in the initial material.

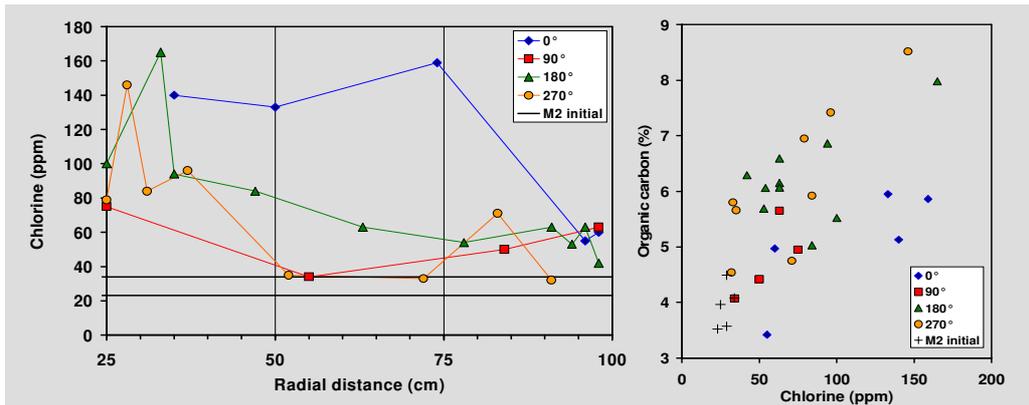
Figure 8-4: Profile of chlorine as a function of the radial distance (LEFT) and correlation between chlorine and organic carbon at section #19 (RIGHT). Black lines represent the min and max values of the initial material.

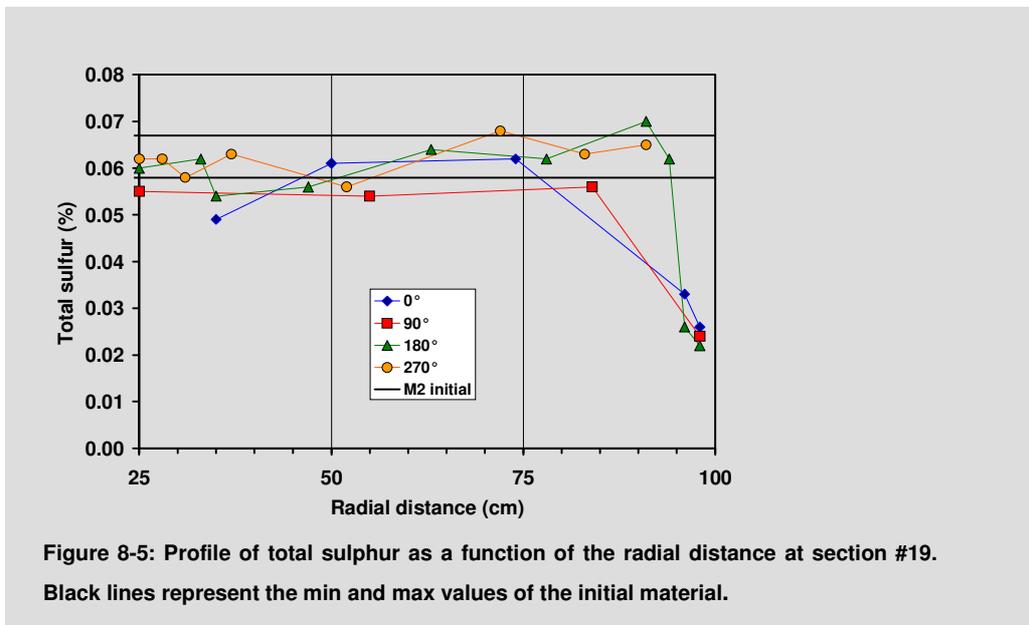
Figure 8-5: Profile of total sulphur as a function of the radial distance at section #19. Black lines represent the min and max values of the initial material.

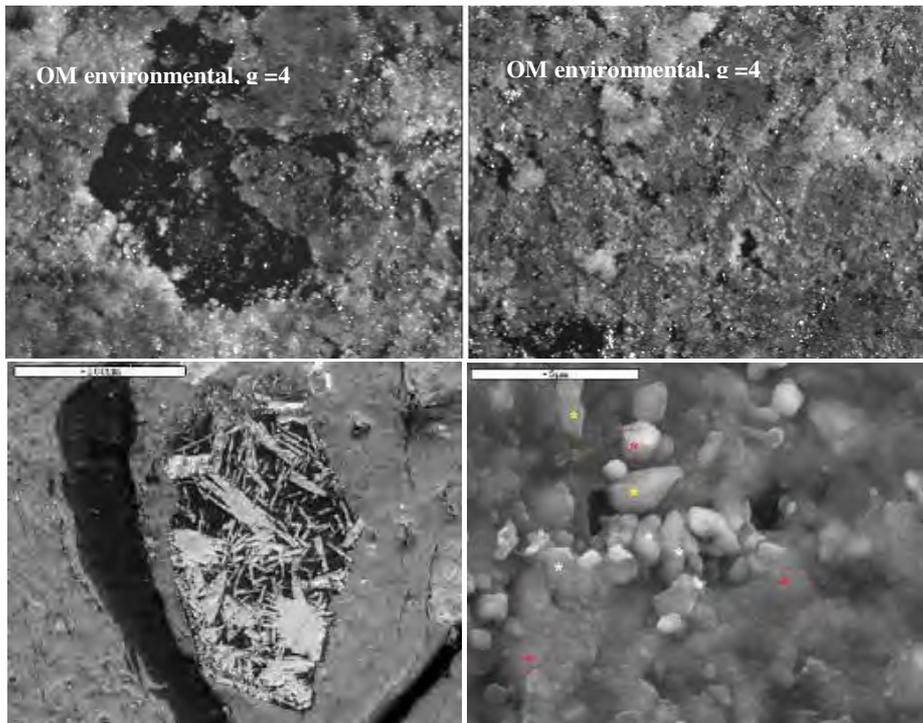
Figure 8-9: Join (about 0.1 mm thick) between two buffer blocks filled by graphite (TOP LEFT). On contact with the liner, the graphite was covered by swelled clay (TOP and MIDDLE RIGHT, pictures taken with an environmental OM and SEM respectively). However, some uncovered graphite foils subsisted (MIDDLE LEFT). Gypsum crystals close to the heater (BOTTOM LEFT). At the interface with the liner, gypsum (yellow crosses) combined with calcite (white crosses) was frequently observed (BOTTOM RIGHT). Red crosses represent quartz.

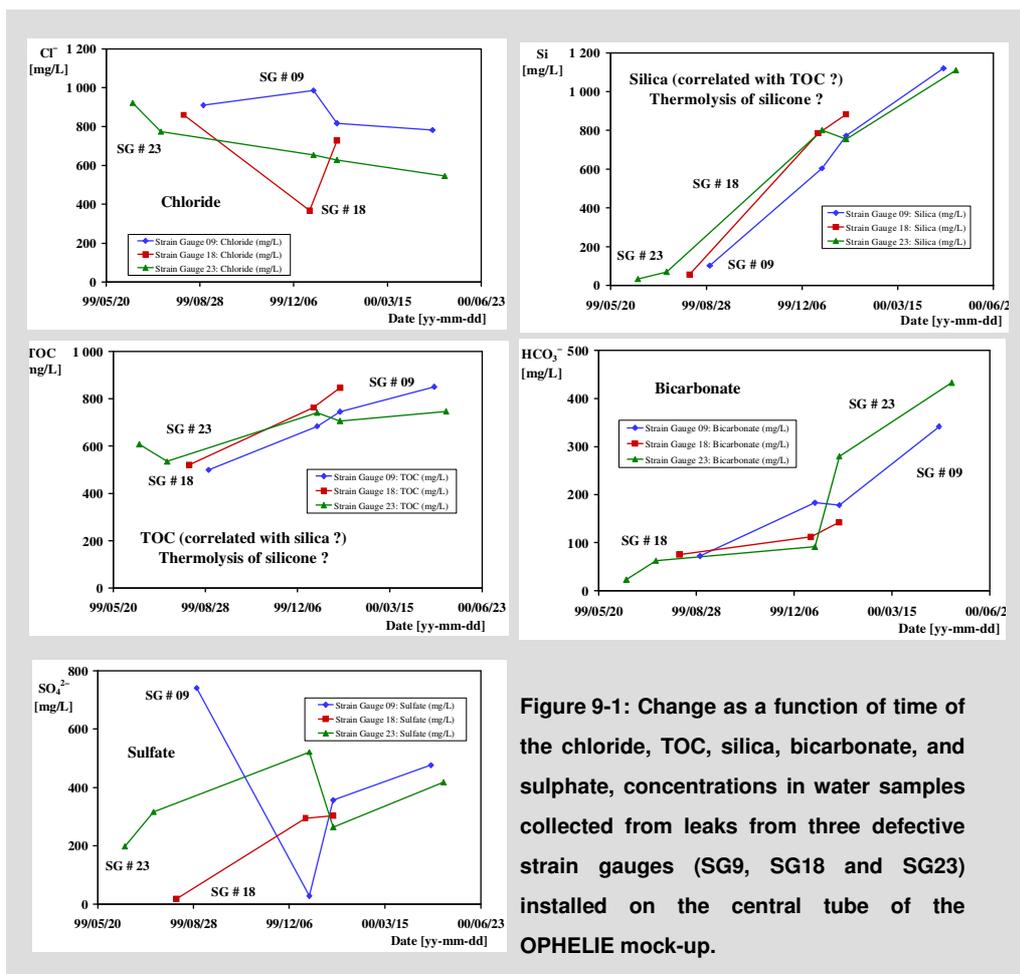
Figure 9-1: Change as a function of time of the chloride, TOC, silica, bicarbonate, and sulphate, concentrations in water samples collected from leaks from three defective strain gauges (SG9, SG18 and SG23) installed on the central tube of the OPHELIE mock-up.

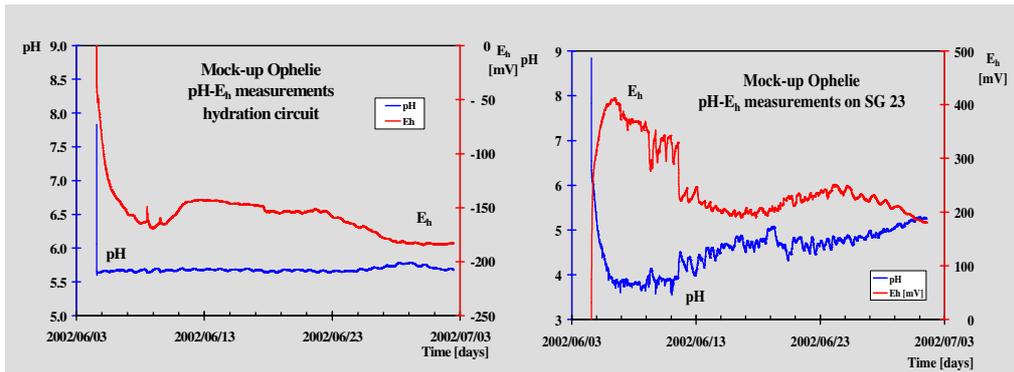
Figure 9-4: On-line pH and Eh (mV, SHE) measurements (June 2002) in the hydration circuit in (LEFT) and in the leak from strain gauge SG23 installed on the central heating tube (RIGHT).

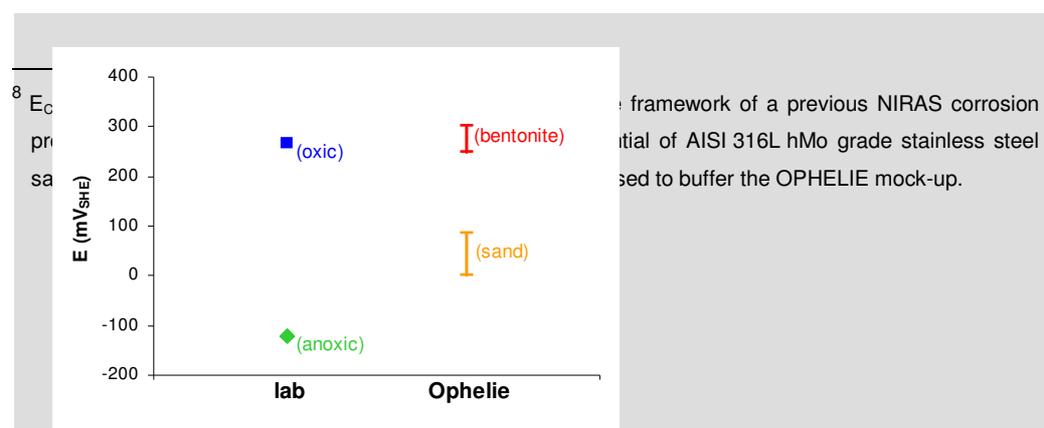
Figure 10-9: Comparison of E_{CORR} values determined in the laboratory and during the dismantling of the mock-up.

The free corrosion potential was determined during dismantling by measuring the potential difference between the central tube and a commercially available Ag/AgCl reference electrode.

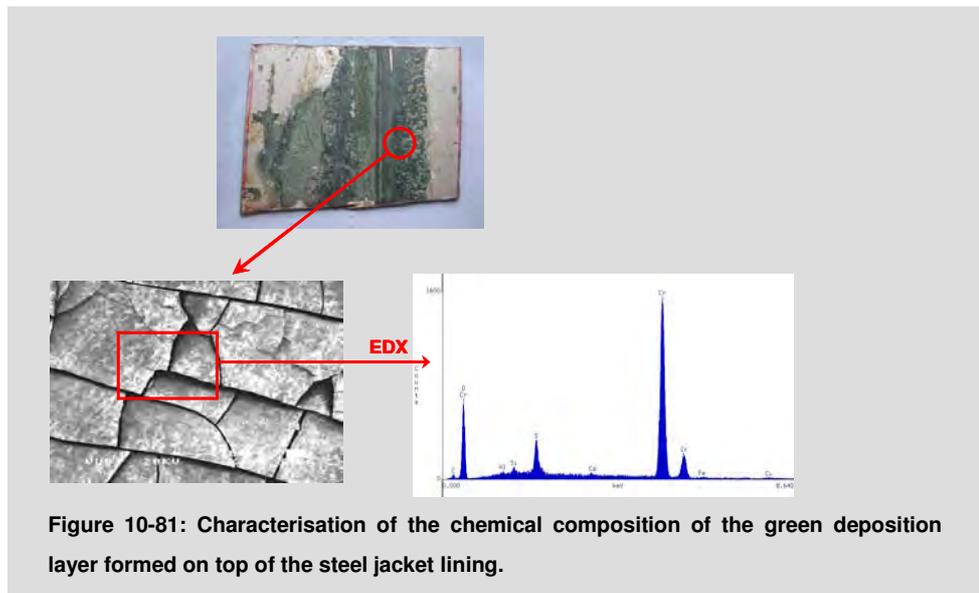
Figure 10-81: Characterisation of the chemical composition of the green deposition layer formed on top of the steel jacket lining.

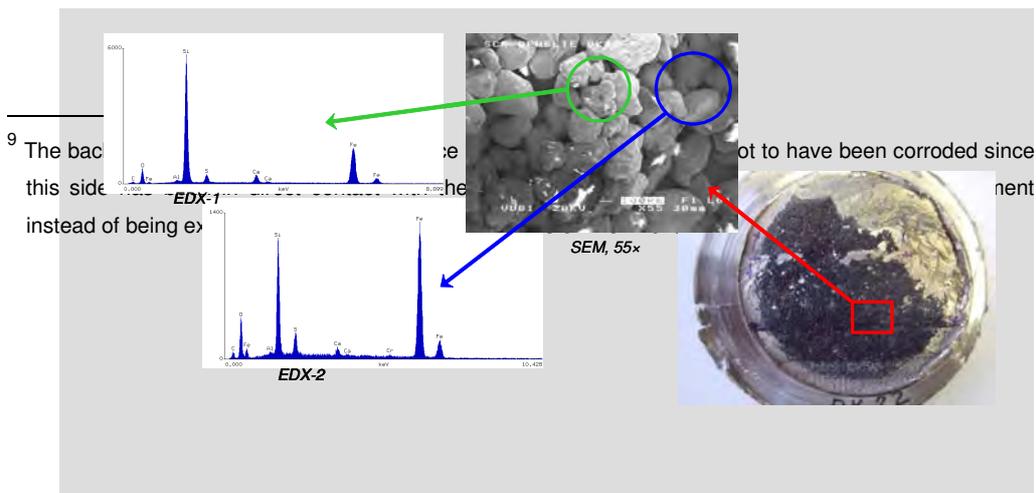
Figure 10-103: Surface morphology and elemental composition (SEM/EDX-analyses) of the purple-brown deposition layer formed on top of the central tube. The grains were partly composed of sand particles (SiO_2) (EDX-1) and partly of a mixture of Fe-S and/or Fe-O compound and sand (EDX-2).

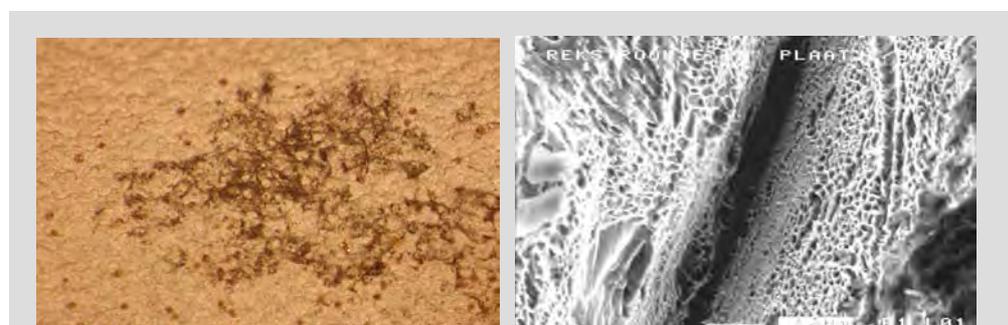
Figure 10-16: Binocular macrograph (magnification: 25×) of the surface of the inner wall of the water supply-tube of hydration tube #15 (part outside the mock-up) showing a cluster of strings (LEFT). SEM-micrograph (magnification: 1,500 ×) of strain gauge SG17 showing a honeycomb-like attack at the weld line (RIGHT).

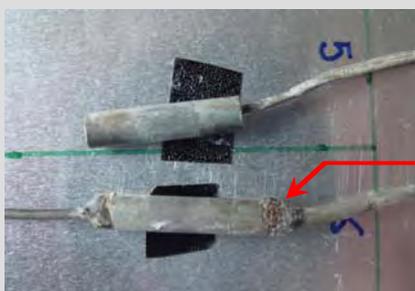
Figure 10-18: Close-up of the sleeves of strain gauges SG5 and SG6. The head of the sleeve of strain gauge SG6 was still present, while that of strain gauge SG5 had completely disappeared.

- the strain gauges seemed to have been attacked at the parts connecting the sleeve with the strain tube on the one hand and with the stainless steel sheath on the other hand. For some of the strain gauges, the connecting parts were found to be entirely corroded (Figure 10-18). For the strain gauges where the connecting part was still present, evidence was found that the connecting part consisted of a stainless steel (machined) head that was soldered (Sn) to the stainless steel sleeve (Figure 10-19). Since such a stainless steel head cannot corrode entirely without leaving a single trace, it was assumed that some of the sleeves were mounted without a stainless steel head. In these cases, the sleeves were probably completely closed with Sn-solder. Evidence of a ductile fracture surface (honeycomb-like shaped appearance) due to overload was also observed (Figure 10-20). This could have been caused during the dismantling operations;

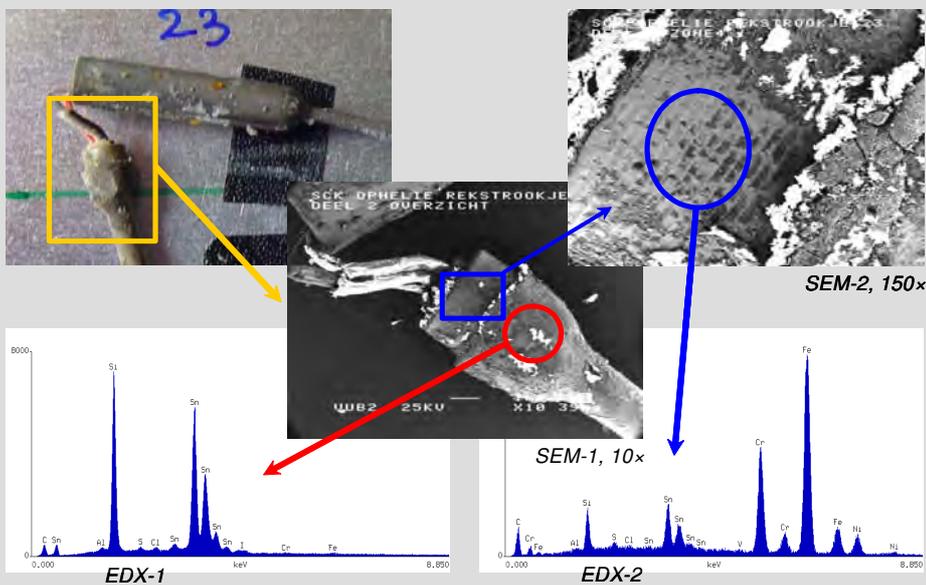
Figure 10-19: Close-up of the head of the sleeve of strain gauge SG23. The head was fabricated from stainless steel and showed signs of machining (SEM-2). The elemental composition of the head (EDX-2) mainly consisted of the typical alloying elements of stainless steel (Fe, Cr and Ni). The surface of the head was entirely covered with soldering material (Sn) (EDX-1).

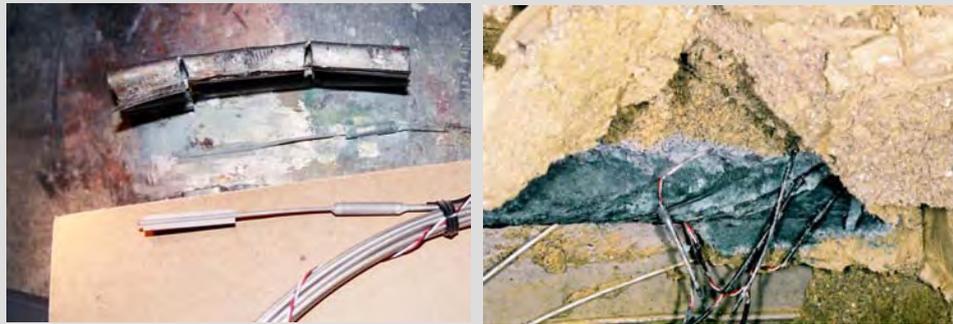
Figure 11-1: Corrosion of the metal sheath (LEFT) and corrosion of the soldered connection part between the sensor and cable (RIGHT).

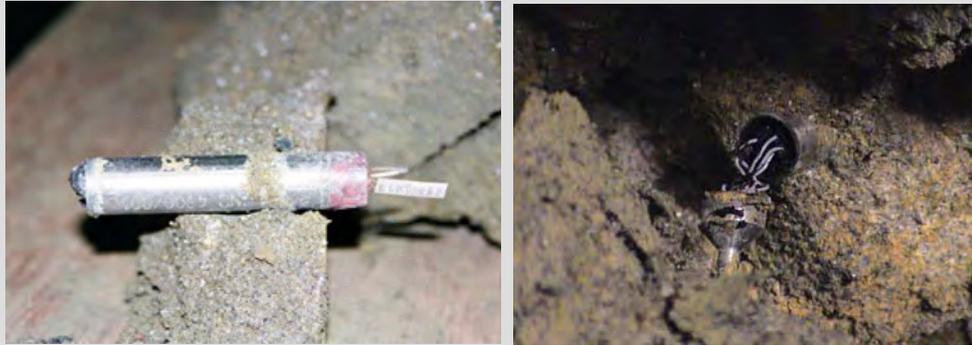
Figure 11-3: Fragile sensor-cable connection (LEFT) and sensor with exposed sensing element as the filter cap was not fixed to the sensor body (RIGHT).

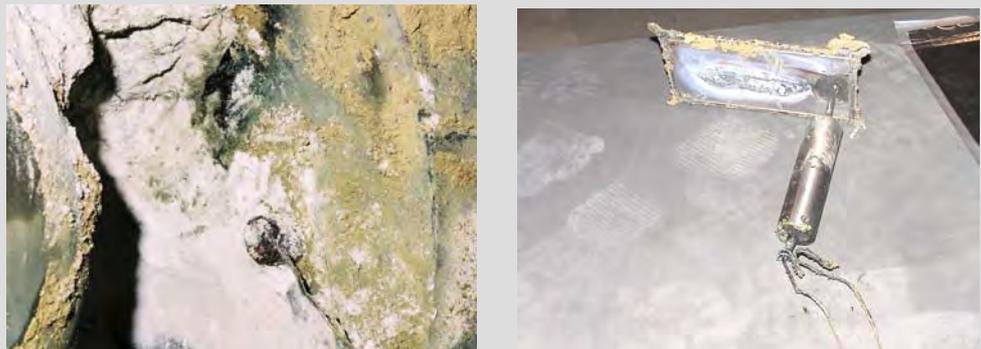
Figure 11-4: Uncovering the RocTest pressure cell (LEFT). The retrieved sensor clearly shows damage at the sensor-cable connection (RIGHT).

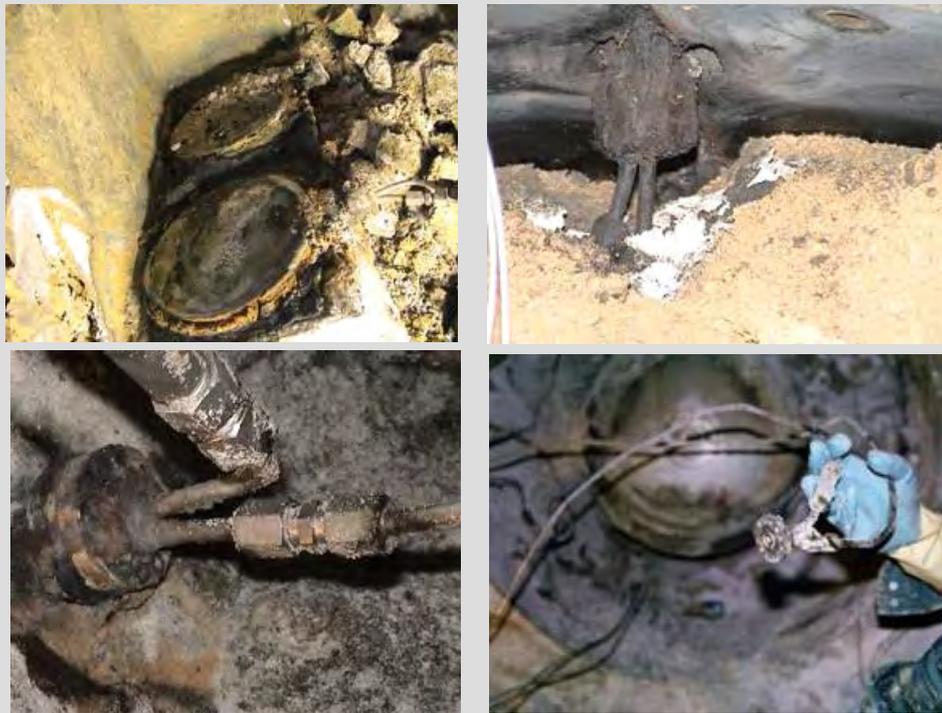
Figure 11-5: Uncovering the load cells after removal of a concrete segment (TOP LEFT). The sensor body protection does not withstand elevated temperatures (TOP RIGHT). Fixing bolts for the sensor body had disappeared (BOTTOM LEFT). The two sensor halves came apart without any effort (BOTTOM RIGHT).

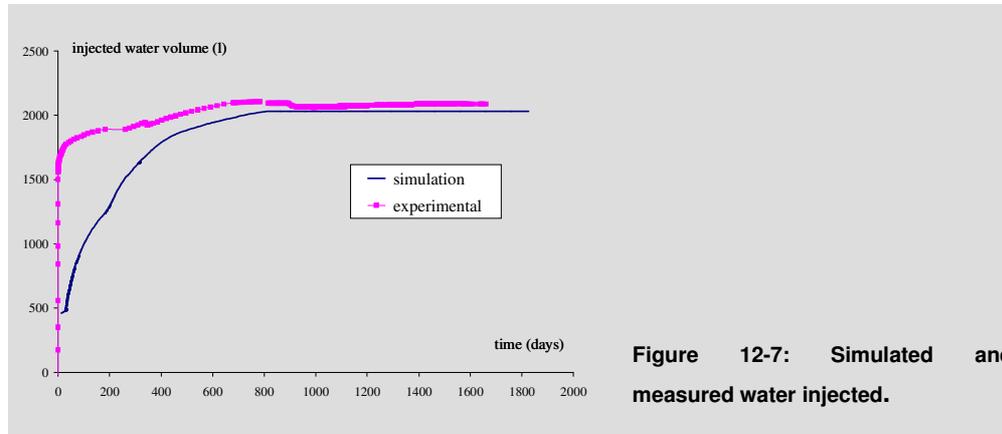
Figure 12-7: Simulated and measured water injected.

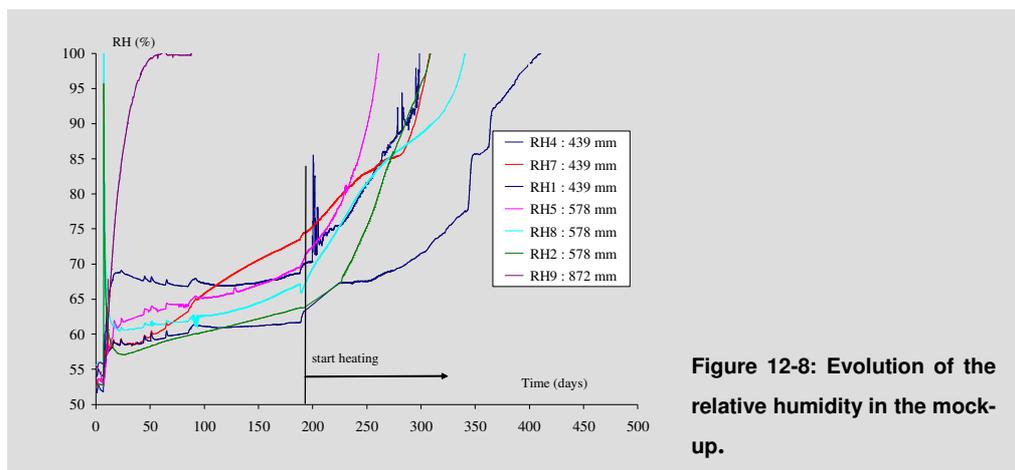
Figure 12-8: Evolution of the relative humidity in the mock-up.

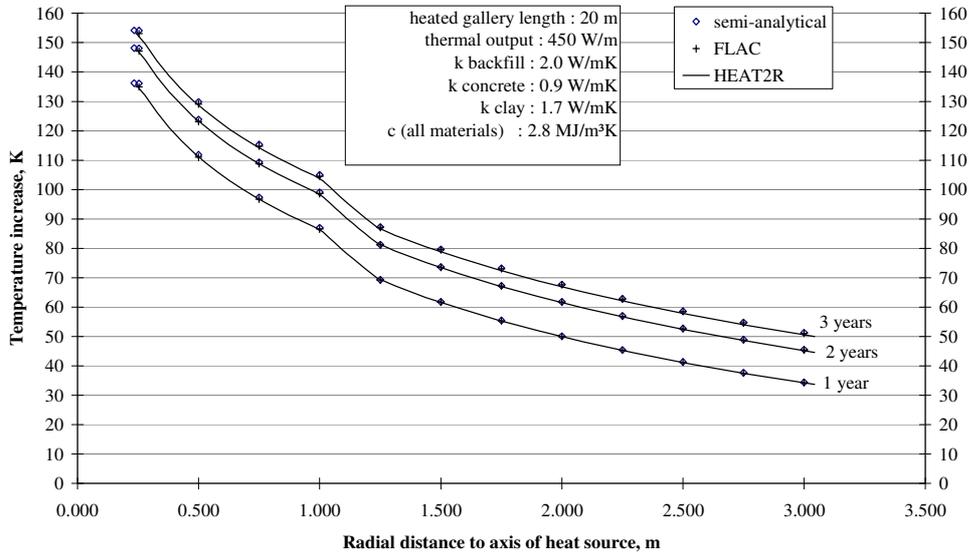
Figure A2-1: The in-situ reference case of the heating was used to define the boundary conditions for the mock-up experiment.

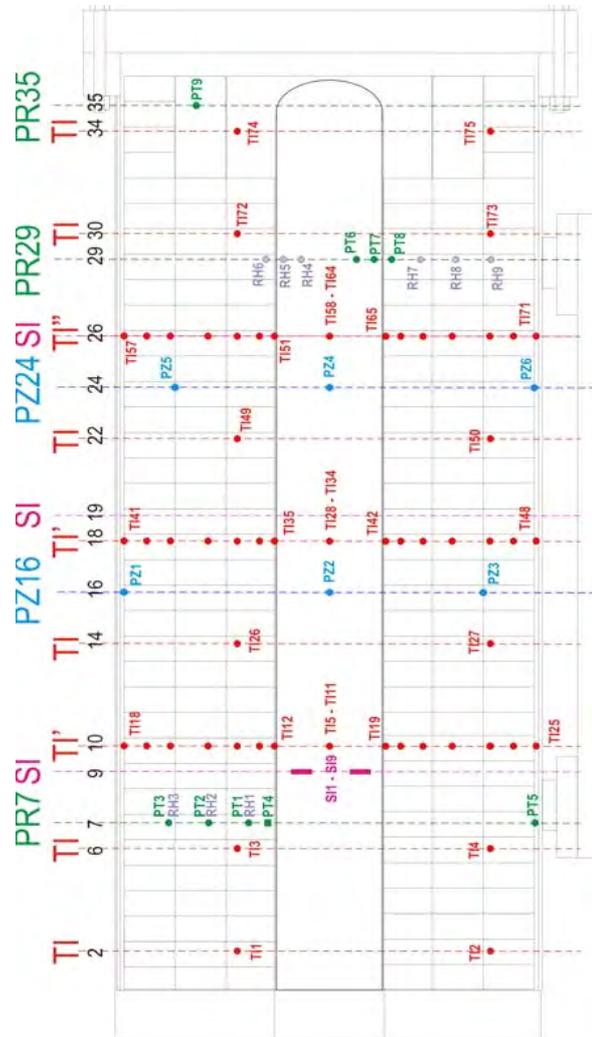
Figure A3-1: Schematic view of the longitudinal section of the OPHELIE mock-up with positions of the different types of sensors (PZ for piezometer, RH for humidity sensor, PT for total pressure cell, TI for thermocouple and SI for internal strain gauge).

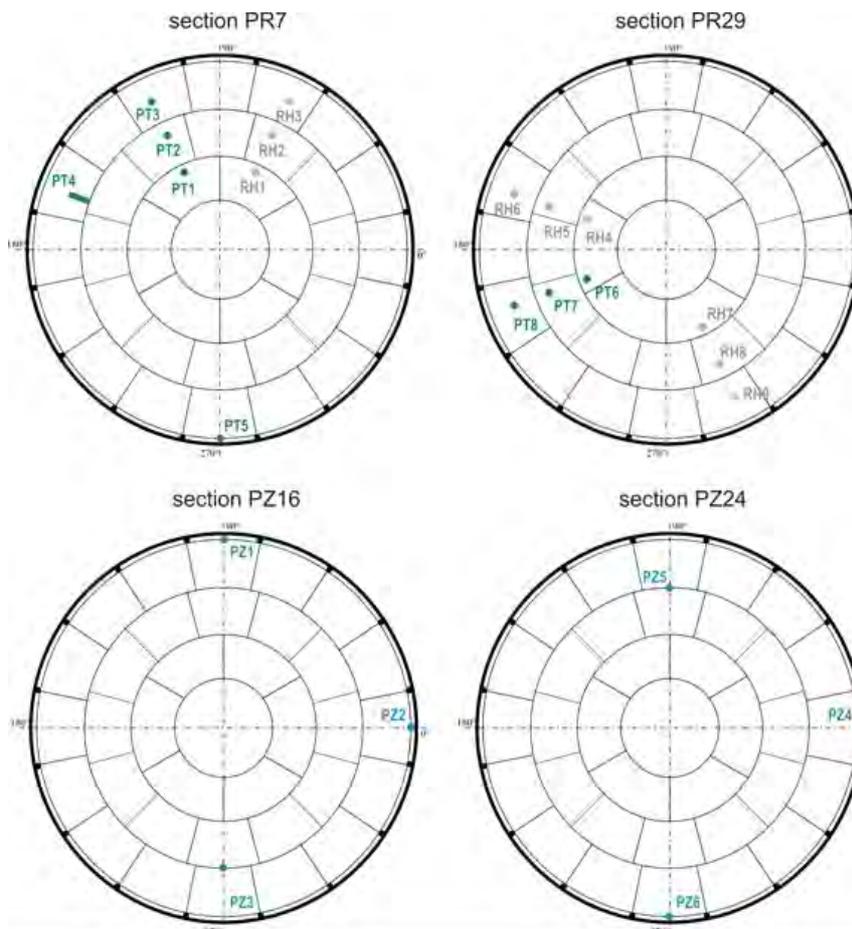
Figure A3-2: Planar position of piezometers, total pressure cells, relative humidity cells for sections #7, #16, #24 and #29.

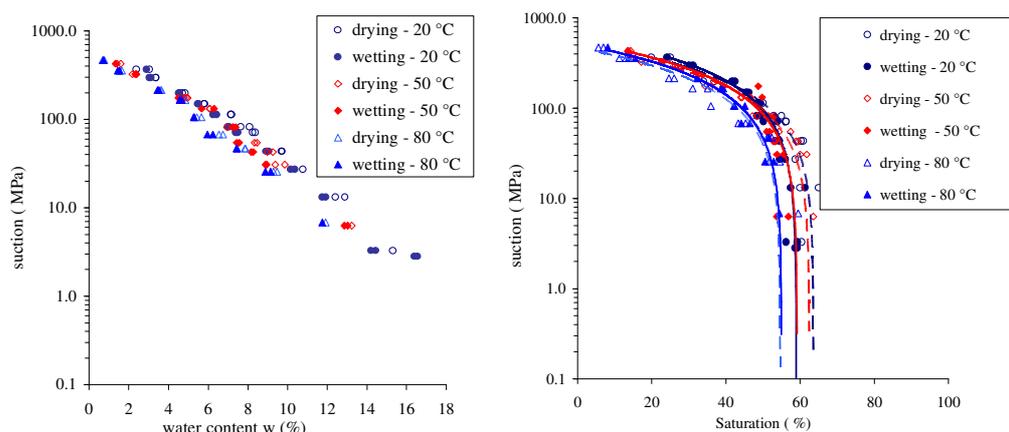
Figure A4-5: Water retention curves at different temperatures.

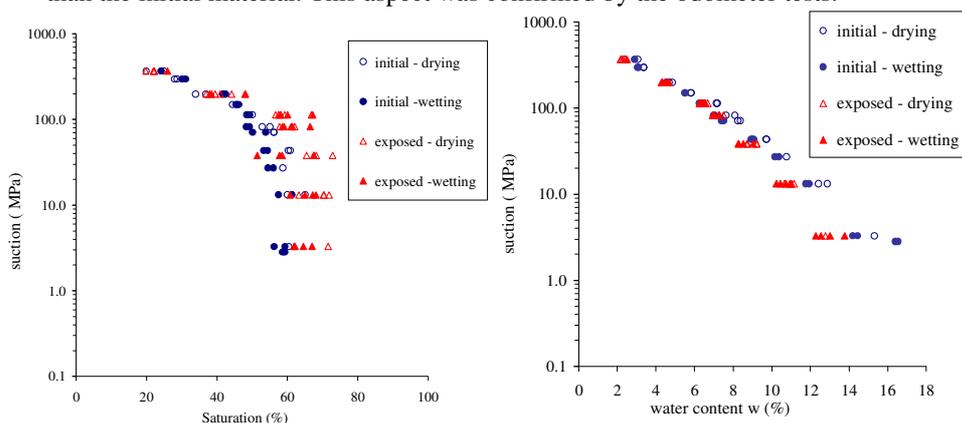
Figure A4-6: Water retention properties for initial and exposed materials

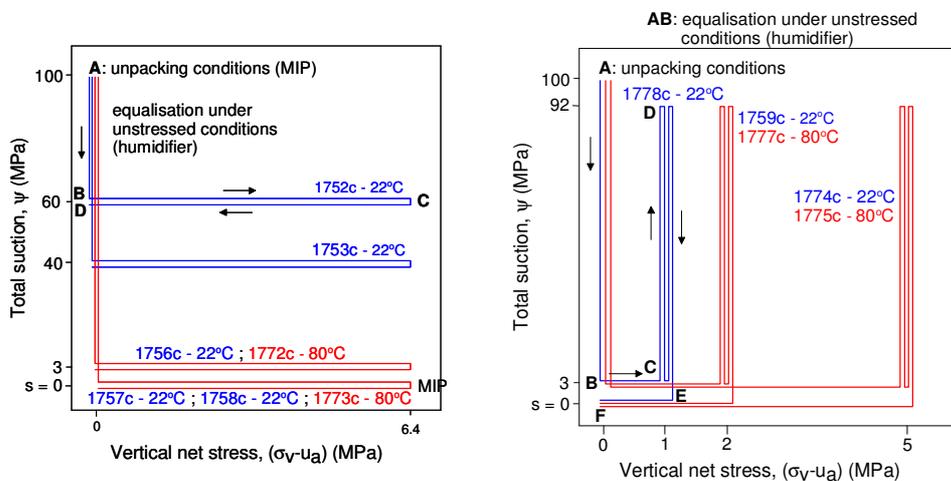
Figure A4-9: Controlled suction level paths for odometer tests. Loading/unloading paths (LEFT) and wetting/drying paths (RIGHT).

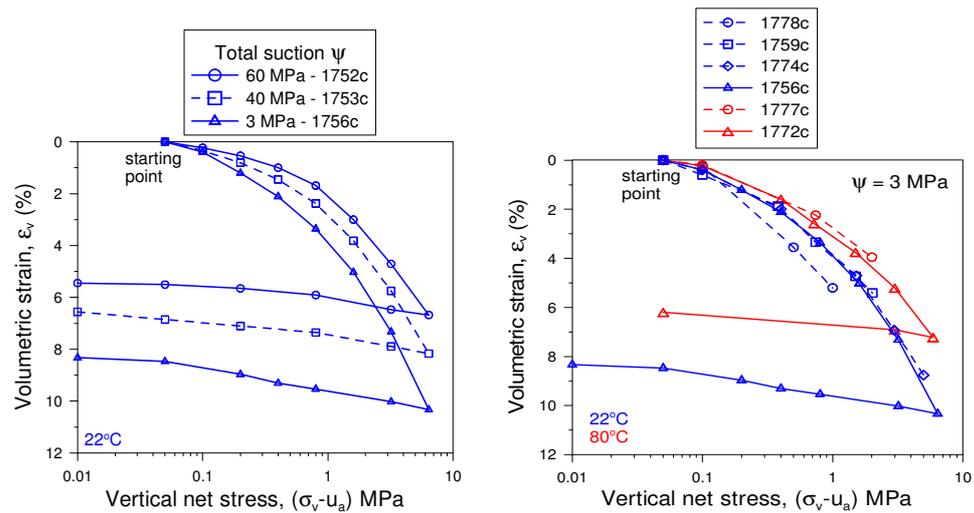
Figure A4-10: Loading/unloading paths at different total suction levels and temperatures.

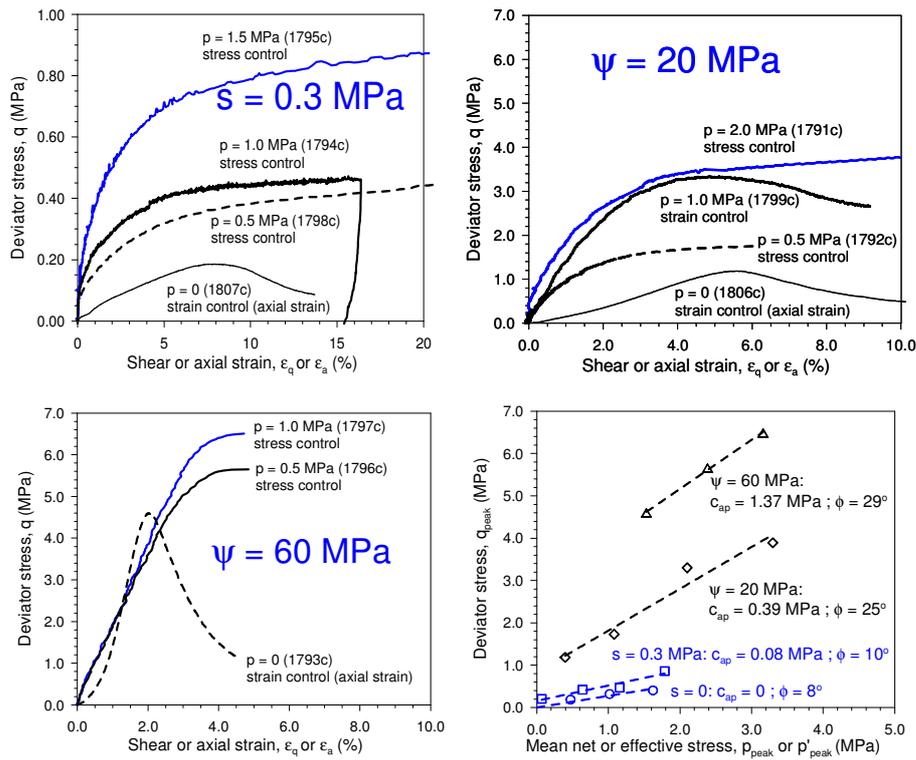
Figure A4-15: Stress-strain curves at different suction levels (TOP and BOTTOM LEFT). Peak strength envelopes at varying suction levels (BOTTOM RIGHT)
