Natural and artificial discontinuities in Boom Clay

Mol (Belgium), February 2000
FB/00-150

EIG PRACLAY

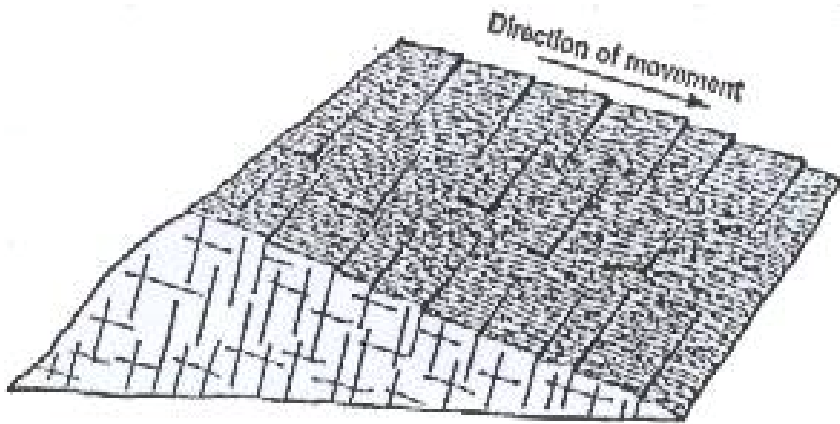
Slickensides (kind of polish, with linear grooves and ridges parallel to the direction of the movement, see Fig. 2) were visible on the slip surface. The shape of the grooves and the ridges indicated a movement in the direction of the centre of the shaft, which can be related to the decompression of the massif (see Fig. 3).

Figure 2: A slickensided surface (Whitten and Brooks, 1972)
