# Characterisation of induced discontinuities in the Boom Clay around the underground excavations (URF, Mol, Belgium)

J. Mertens<sup>a,\*</sup>, W. Bastiaens<sup>b</sup>, B. Dehandschutter<sup>c</sup>

Excavation works were carried out in Boom Clay to extend the underground research facility in Mol (Belgium) located at a depth of 223 m below the surface. The attempt to characterise the extent of the Excavation Damaged Zone, or EDZ, around the second shaft, using seismic measurements and cored borings, was successful, as proven by observations during further excavation works in the investigated area. No evidence for the occurrence of natural discontinuities was found. Using an industrial technique, an 84-m-long gallery was excavated in the Boom Clay. These excavation works induced a symmetrical pattern of discontinuities and clearly limited the EDZ extent.

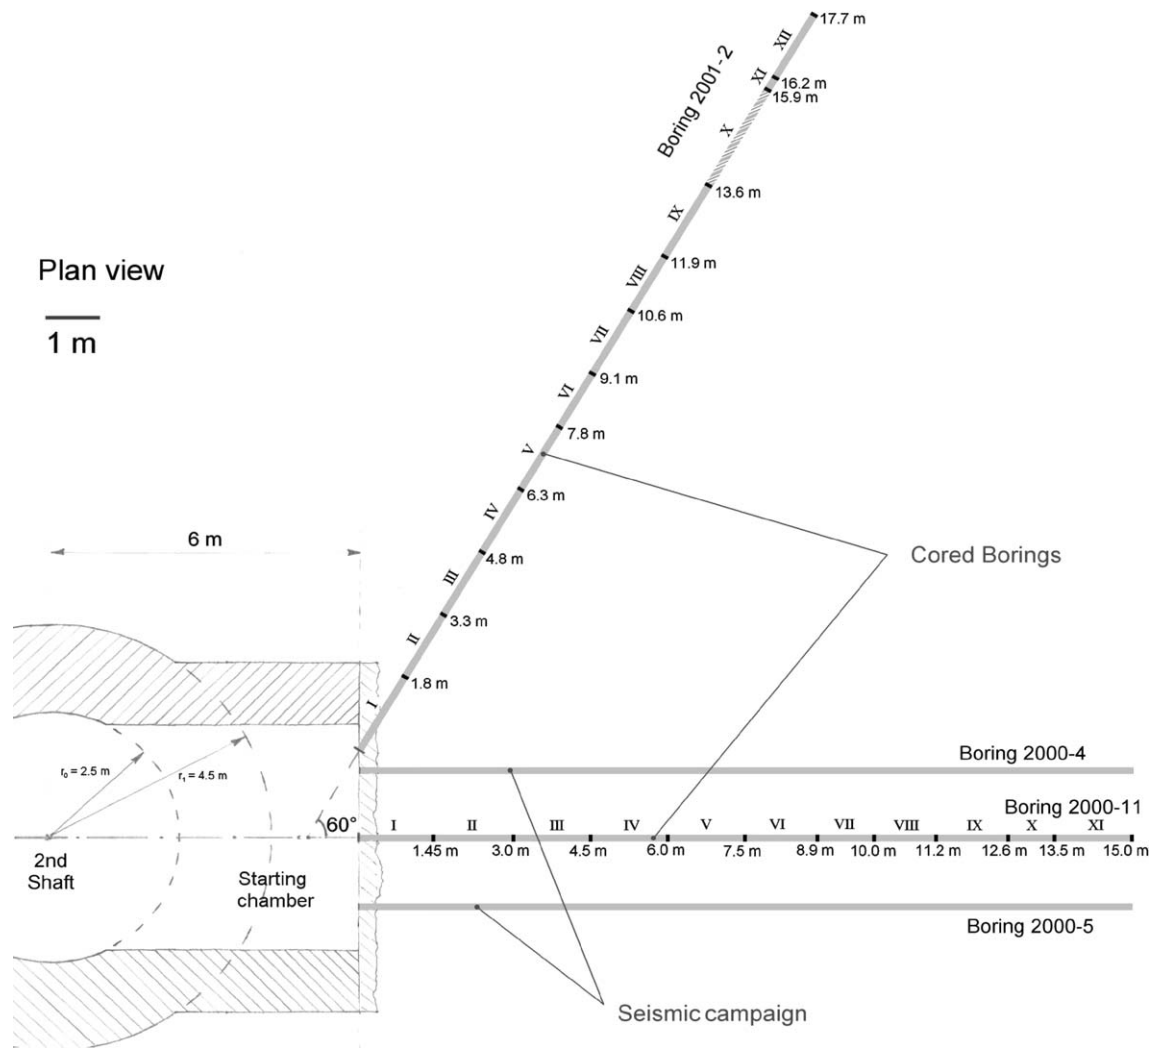
Fig. 3 gives a plan view of the second shaft and the northern Starting Chamber, showing the location of four horizontal boreholes. Two of them, 2000–4 and 2000–5, were used for the seismic campaign. The other two, 2000–11 and 2001–2, were cored.

Fig. 3. Plan view of the second shaft at the depth of the northern Starting Chamber. The location of the boreholes used for seismic measurements (2000–4 and 2000–5) and the cored borings (2000–11 and 2001–2) are indicated.

~ 4.5 m) ranges up to approximately 12 m from the axis of the second shaft into the clay (this is about 6 m behind the wall of the Starting Chamber, see Fig. 3).

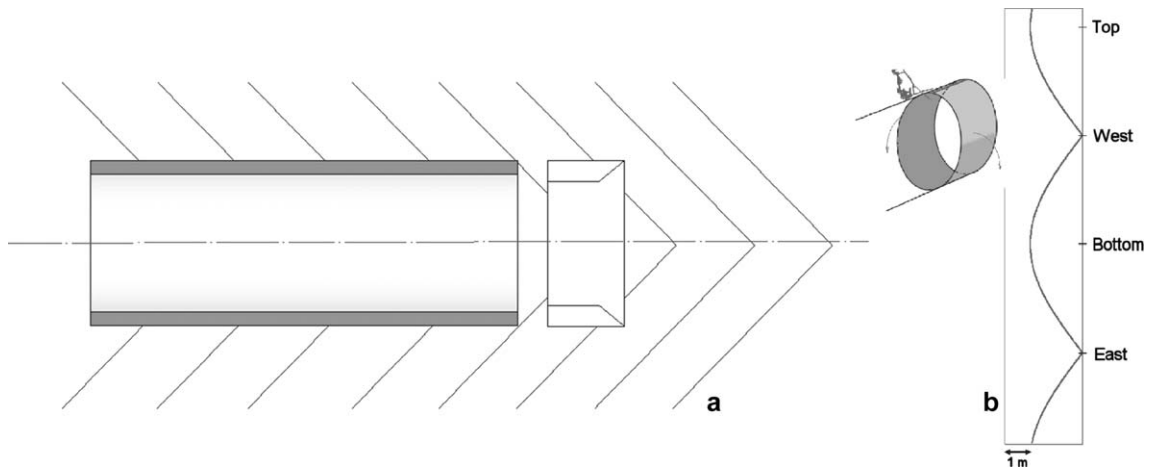
Fig. 16. Analytical calculations of the cross-section of a plane dipping  $50^{\circ}\text{N}$  and  $50^{\circ}\text{S}$  with a cylinder. (a) Simplified fracture pattern. (b) Intersection trace.

If the fracture pattern is simplified to two flat fracture planes (one dipping  $50^\circ\text{N}$ , the other  $50^\circ\text{S}$ ) with a trend perpendicular to the gallery axis, the theoretical trace on the gallery sidewalls in the unsupported zone can be calculated as the intersection of the two planes with a cylinder (Fig. 16a). The calculated trace can be found in Fig. 16b: it shows an unfolded cylinder and one band corresponding to 1 m.

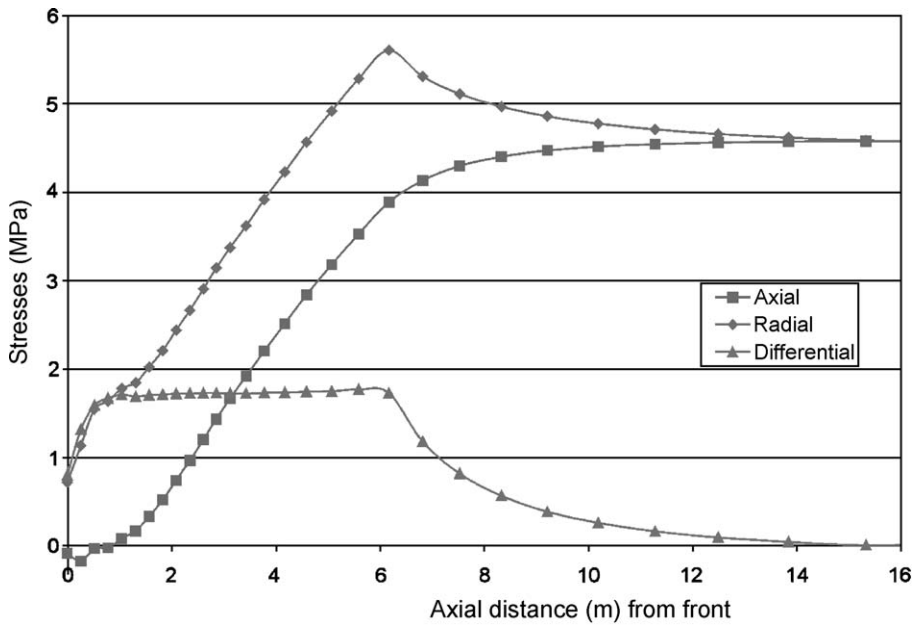
Fig. 20 maps the result of a simplified 2D axisymmetrical Cam clay model, showing axial, radial and differential stresses along the gallery axis. In this case, the initial stress state was chosen to be isotropic (total initial stresses = 4.6 MPa, initial water pressure = 2.2 MPa) which was a slight simplification as  $K_0$  is expected to be 0.9 (SAFIR II). In addition, the clay itself was chosen to be isotropic. Modelling shows that the stress peak is reached 6 m ahead of the

Fig. 20. Modelled stresses (axial, radial and differential) along the gallery axis, ahead of the excavation front (2D axisymmetrical model, using FLAC-code). In this case, the initial stress state was chosen to be isotropic (total initial stresses=4.6 MPa, initial water pressure=2.2 MPa) which was a slight simplification as  $K_0$  is expected to be 0.9 (SAFIR II).

excavation front. It is therefore expected that the fractures are formed several meters ahead of the face.

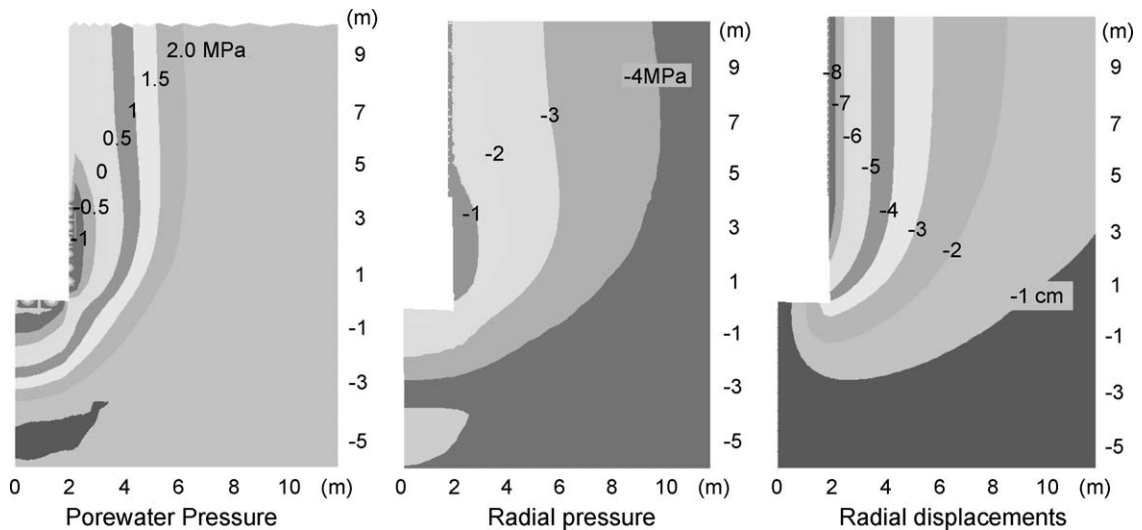
theoretically. It can be explained by the stress redistribution ahead of the gallery face. 2D axisymmetrical Cam clay modelling clearly shows the response of the host rock when a gallery is excavated (Fig. 21)

Fig. 21. Modeling results for the spherical response of the host rock when a gallery is excavated (after Bernier and Van Cauteren, 1998). Same boundary conditions as the modeling in Fig. 20 were used.

(Bernier and Van Cauteren, 1998). This corresponds with the curved fracture planes observed in a vertical plane through the Connecting Gallery (Fig. 15). The anisotropy of the fracture pattern, however, needs to be considered. While observations suggest radial isotropy of the fractures in case of the second shaft, this is not the case for the connecting gallery. Possible explanations for this difference in shapes can be the fact that the vertical initial stress is in fact slightly larger than the horizontal one ( $K_0=0.9$ ), or the fact that the clay itself, consisting of compacted clay laminates, is not quite isotropic when comparing a vertical and horizontal section.
